## BOSTON REGION METROPOLITAN PLANNING ORGANIZATION

### MEMORANDUM

**DATE** December 6, 2012  
**TO** Boston Region Metropolitan Planning Organization  
**FROM** Mark Abbott and Christine Bettin  
MPO Staff  
**RE** Safe Access to Transit for Pedestrians and Bicyclists: Braintree Station

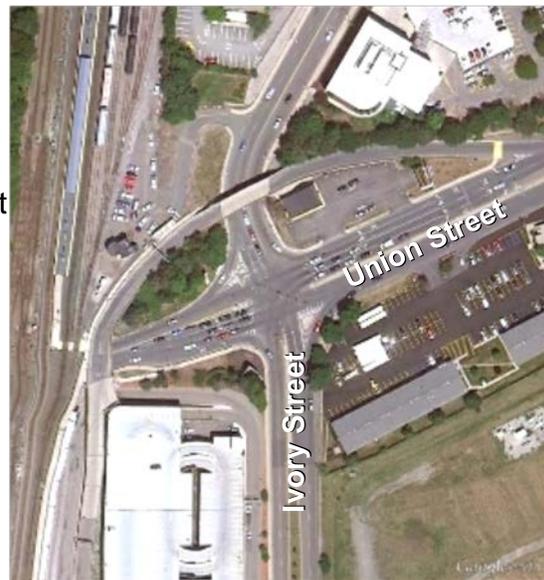
**Ivory and Union Streets**

The west and north legs of the intersection of Ivory and Union streets have ladder-style crosswalks. The west leg also has pedestrian signals and pedestrian curb-cut ramps, although the ramps do not have detectable warning pads. The west leg has two pedestrian refuge islands with curb cuts, and pedestrian signals that create a three-step crossing (stopping at two islands in the roadway). The crossing distance between the southwest corner and the first island is approximately 64 feet. The pedestrian signal timing provided when the push button on the southwest corner is activated is 19 seconds; however, when the push button is activated from the first island, the pedestrian signal timing is 17.5 seconds. Based on a walking speed of 3.5 seconds per foot, the minimum pedestrian signal timing for a crossing distance of 64 feet is 18.3 seconds. The crossing from the second island to the northwest corner is not signalized, since there are channelized right-turn movements from southbound Ivory Street onto westbound Union Street.

The north leg of this intersection does not have a pedestrian signal and the ramps do not have detectable warning pads. The lack of a pedestrian signal combined with a crossing distance of approximately 75 feet creates an unsafe environment for pedestrians. The longest uninterrupted crossing a pedestrian should encounter at a crosswalk is 50 feet.<sup>6</sup>

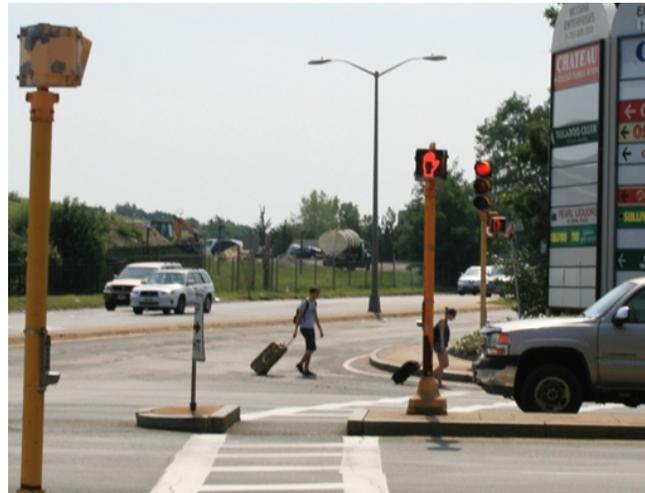
**Ivory Street, SB: Motel 6 guests crossing the south leg**

There are no crosswalks provided on the east and south legs of this intersection. There is a Motel 6 located on the southeast corner of this intersection that creates a demand for a signalized and marked crossing for the south leg. During the site visit, several Motel 6 guests were observed crossing the south leg while traveling to and from Braintree Station, oftentimes while pulling luggage.

- Stripe a ladder-style crosswalk along the south leg of this intersection. Ladder crosswalks are more visible than simple parallel lines, especially at night or in low-light conditions. This would require constructing a pedestrian landing at the southeast corner of Union and Ivory streets with pedestrian access to Motel 6, construction of curb-cut ramps through the channelizing island, and installation of an accessible pedestrian signal with countdown features. The pedestrian signal should not interfere with the traffic signal timing, since this intersection has an almost-exclusive pedestrian phase.

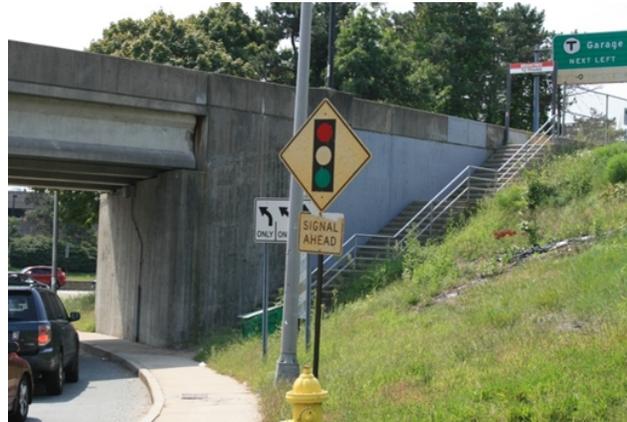
There is an elevated pedestrian walkway that connects Braintree Station to the commercial properties north of Union Street. Access to the walkway for the commercial properties is provided by a steep staircase that is not fully accessible and that has only one “Braintree Station” sign, at the top of the stairs.

**Access to the Braintree Station elevated pedestrian walkway**

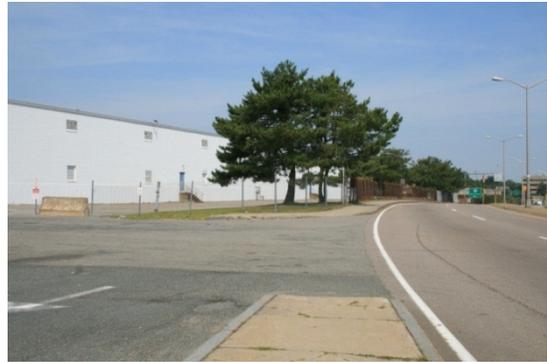
There are two access driveways to the shopping center along the west side of Ivory Street between Union and Pearl Streets. The southern access driveway has a crossing distance of approximately 90 feet, a stop sign, stop bar, and crosswalk. The northern access driveway has no crosswalk and has a crossing distance of approximately 75 feet.

**Ivory Street: Shopping center access driveway (no crosswalk)**

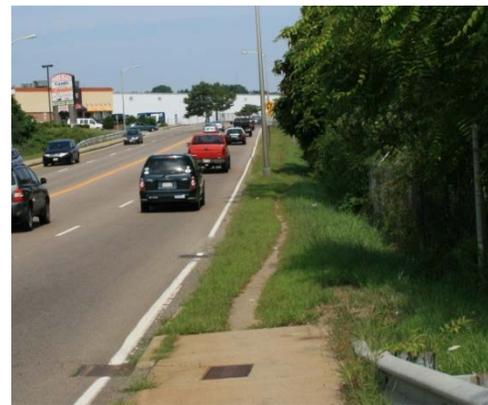
There is no crosswalk on the east leg of the intersection, since the sidewalk on the northeast corner of the intersection terminates on the approach to Ivory Street. After the sidewalk terminates, there are signs of pedestrian activity from a worn path in the grass leading up to the entrance of the Braintree Transfer Station. At this point, the strip of grass becomes very narrow and there is a fence blocking further access. This forces pedestrians to cross Ivory Street at an unmarked and unsignalized location. This pedestrian activity may be a result of the proximity of Jonathans Landing, which has approximately 700 owner-occupied units, as well as from the residential area located southwest of Braintree Station.

**Ivory and Pearl streets:  
Sidewalk terminus with worn  
path**

- Install MBTA wayfinding signs on the northeast and southeast corners of Ivory Street, Pearl Street, and John W. Mahar Highway directing pedestrians to cross over Ivory Street and John W. Mahar Highway for access to Braintree Station.
- Repair the pedestrian signal head on the southwest corner of this intersection.
- Upgrade the pedestrian signal heads with countdown features.
- Install ADA-compliant detectable warning pads on all pedestrian curb-cut ramps.

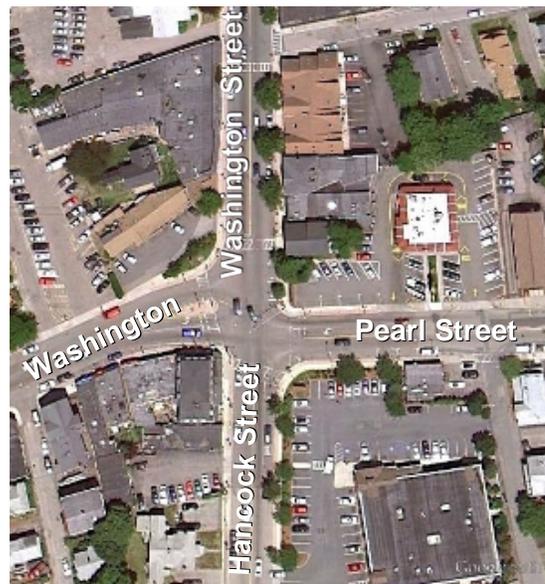
**Hancock, Pearl, and Washington streets**

All legs of this intersection have ladder-style crosswalks and pedestrian activated signals, where pushing a button results in an exclusive pedestrian phase. The pedestrian signal head on the northeast corner does not light up when activated. The crossing on the west leg has a pedestrian refuge island and a total crossing distance of approximately 72 feet, with a pedestrian signal timing of 19 seconds. Based on a walking speed of 3.5 seconds, the minimum pedestrian signal timing for a crossing distance of 72 feet is 21 seconds. The sidewalks throughout the intersection are in good condition. All corners of the intersection have pedestrian curb-cut ramps, although the ramps do not have detectable warning pads.

- Repair the pedestrian signal head on the northeast corner of Washington, Pearl, and Hancock Streets.
- Increase the pedestrian signal timing to 21 seconds.
- Upgrade to accessible pedestrian signals with countdown features.
- Install ADA-compliant detectable warning pads on all pedestrian curb-cut ramps.

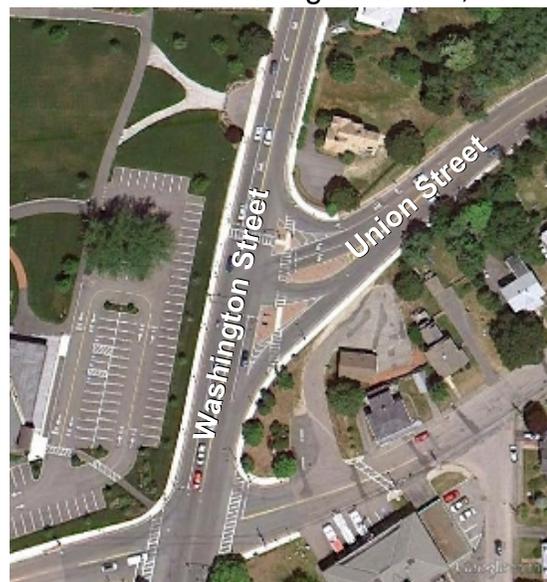
**Union and Washington streets**

The east and north legs of this intersection have ladder-style crosswalks. The crosswalk on the east leg has a crossing distance of approximately 127 feet, broken up by two pedestrian refuge islands. There are pedestrian-activated signals only between the two islands, and none for the continuous right-turn lanes. The crosswalk on the north leg has pedestrian-activated signals. Activating the pedestrian signals results in a concurrent pedestrian phase. The pedestrian signal timing is sufficient for the lengths of crossings at this intersection.

The sidewalks are approximately 6 feet in width and in good condition throughout the intersection. All corners of the intersection have pedestrian curb-cut ramps, although the ramps do not have detectable warning pads. There appears to be adequate lighting along Washington Street, provided by pedestrian-scale light posts. There are no bicycle-specific features at this intersection.

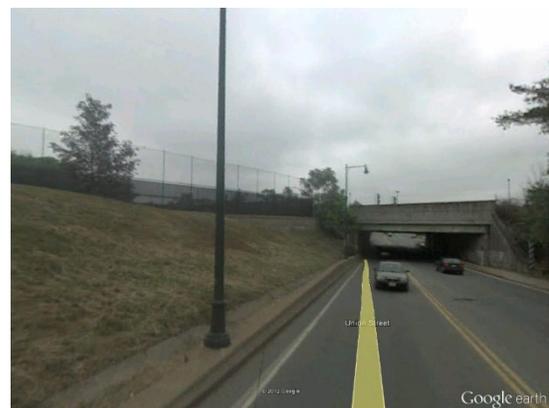
On the northern side, the sidewalk ends at the corner of Washington Street and Union Street. However a path has been worn by pedestrians from the end of the sidewalk to where the bridge abutment begins. Pedestrians then cross Union Street to the southern sidewalk; crossing midblock, where there is no crosswalk.

**Union Street:** location for north-side sidewalk and pedestrian bridge

- Construct a new sidewalk on the northern side of Union Street from continuing from where it currently ends, at the Washington Street intersection.

- Construct a pedestrian bridge from the end of the new sidewalk on the north side, and over the train tracks, to the existing pedestrian walkway that leads from the Union Street and Ivory Street intersection to the station. The grade changes of the terrain would help with the approach to the new pedestrian bridge over the train tracks. (Another option that was examined was adding pedestrian bridge at the end of Union Place. This option would not be as likely to improve access for Union Street pedestrians and would also likely attract more kiss-and-ride users along Union Place, which is a residential street.
