BOSTON REGION METROPOLITAN PLANNING ORGANIZATION

TECHNICAL MEMORANDUM

DATE: August 17, 2023
TO: Valerie Oorthuys, Town of Stow
FROM: Casey Cooper, Boston Region MPO
Julie Dombroski, Boston Region MPO
RE: Stow Intersection Improvement Study

This memorandum summarizes the analyses and improvement strategies for the intersection of Route 117 and Route 62 in Stow, also known as the intersection of Great Road, Library Hill Road, and Gleasondale Road.

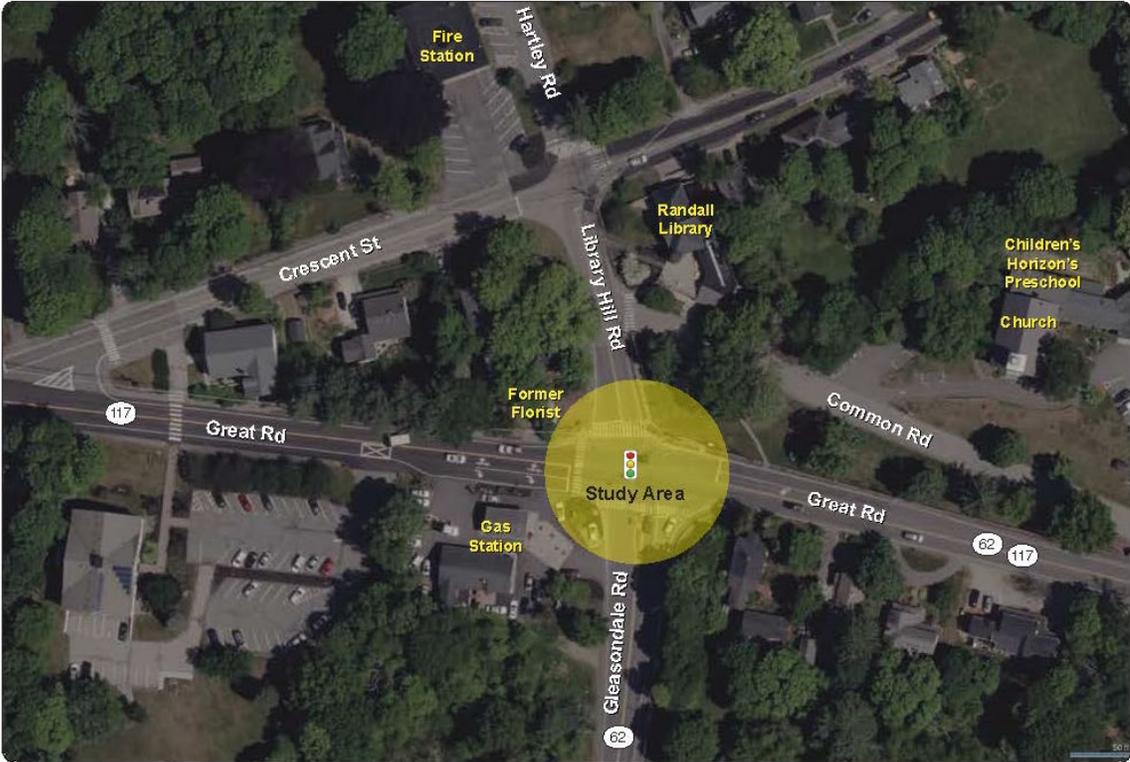
Figure 2
Intersection Study Area

The northwest corner of the intersection features the former One Main Street Studio florist building; the southwest corner of the intersection is home to a gas station; and the southeast corner of the intersection is residential, with a low stone wall marking the edge of the property. The study intersection and its surrounding destinations are illustrated in Figure 2.

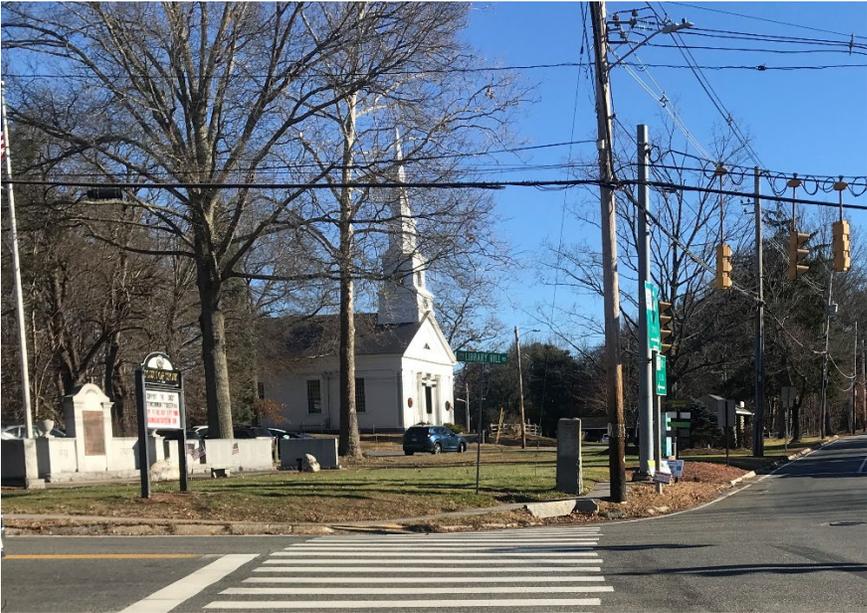
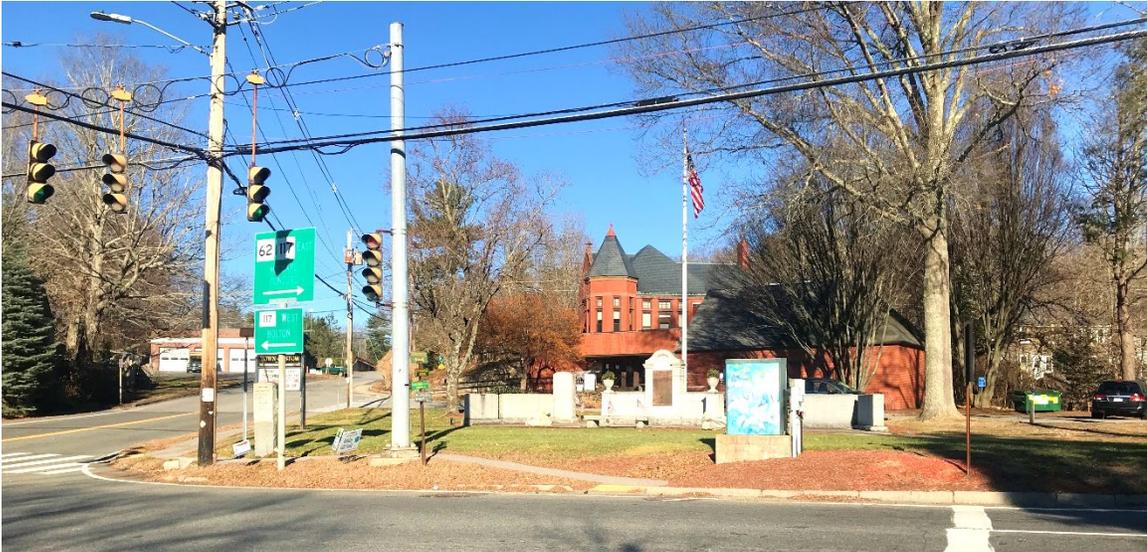
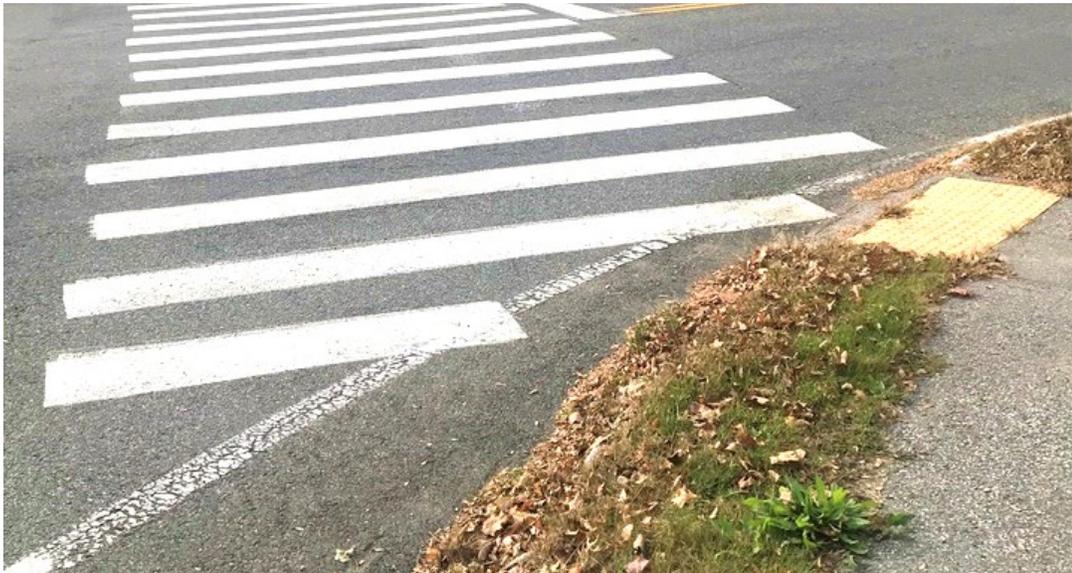
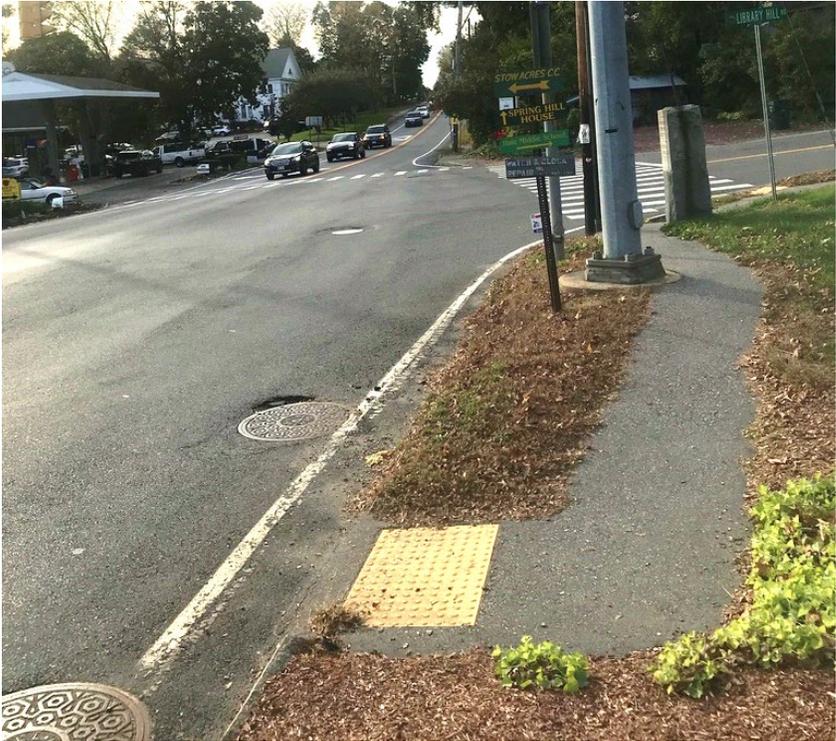
The northeast corner of the study intersection includes a sidewalk along Library Hill Road, but it does not continue along Great Road (Routes 117 and 62). There are two curb ramps on the northeast corner, both of which include a pedestrian detectable warning strip, but only Library Hill Road is painted with a crosswalk to direct pedestrians across the intersection and increase driver awareness of people walking.

Figure 3
View across Library Hill Road of Northeast Intersection Corner

Figure 4
View across Great Road (Routes 117 and 62) of Northeast Intersection Corner

Figure 5
Pedestrian Facilities for Northeast Intersection Corner's
Library Hill Road Crossing

Figure 6
Great Road (Route 117 and 62) Crossing on Northeast Intersection Corner
with Pedestrian Detectable Warning Strip Lacking Crosswalk

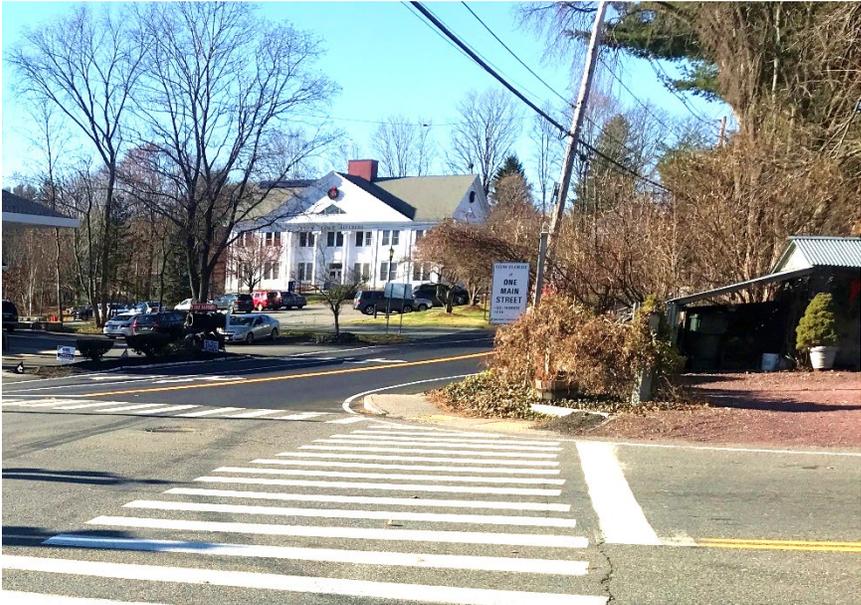
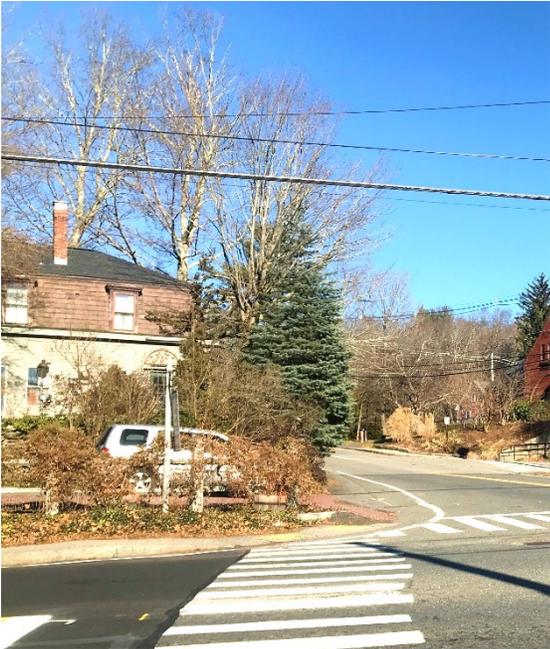
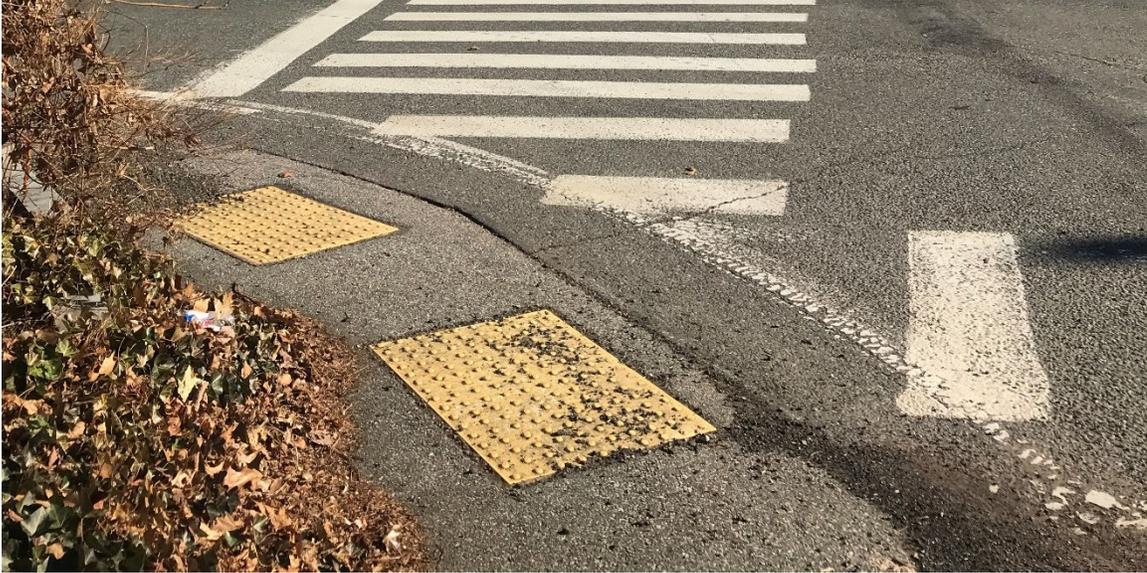
The northwest corner of the study intersection is the only corner that includes a sidewalk, a curb ramp, and both a crosswalk and a pedestrian detectable warning strip for both directions of travel, although the sidewalk does not extend up Library Hill Road and only travels west along Great Road (Route 117).

Figure 7
View across Library Hill Road of Northwest Intersection Corner

Figure 8
View across Great Road (Route 117) of Northwest Intersection Corner

Figure 9
Northwest Intersection Pedestrian Facilities

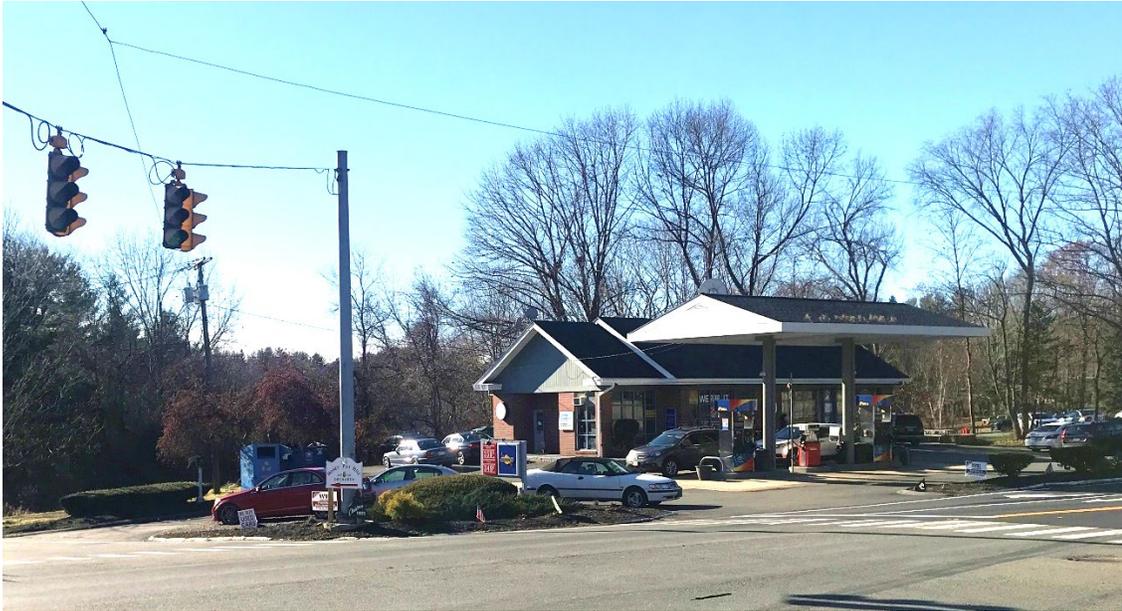
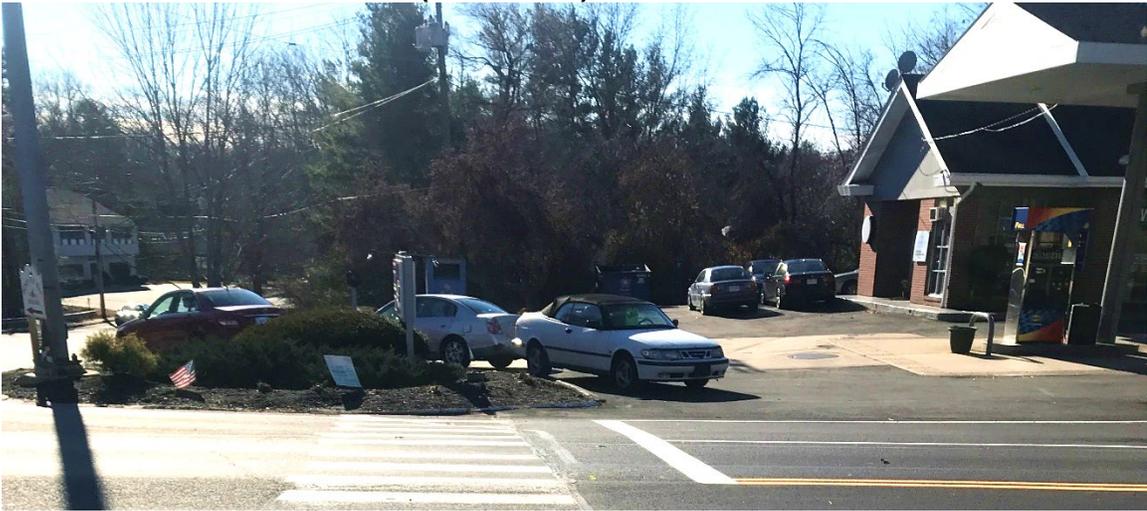
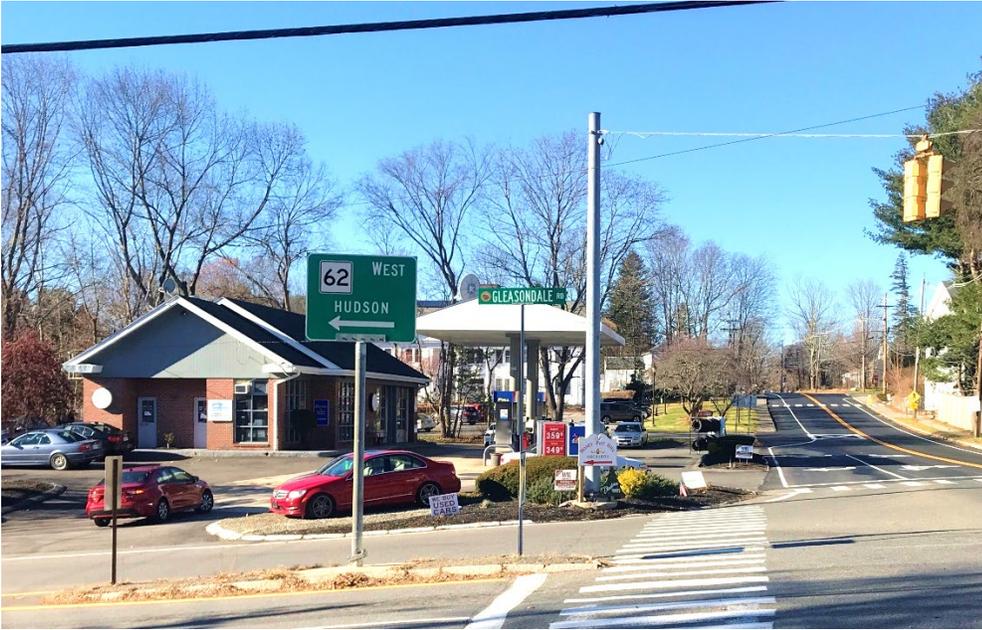
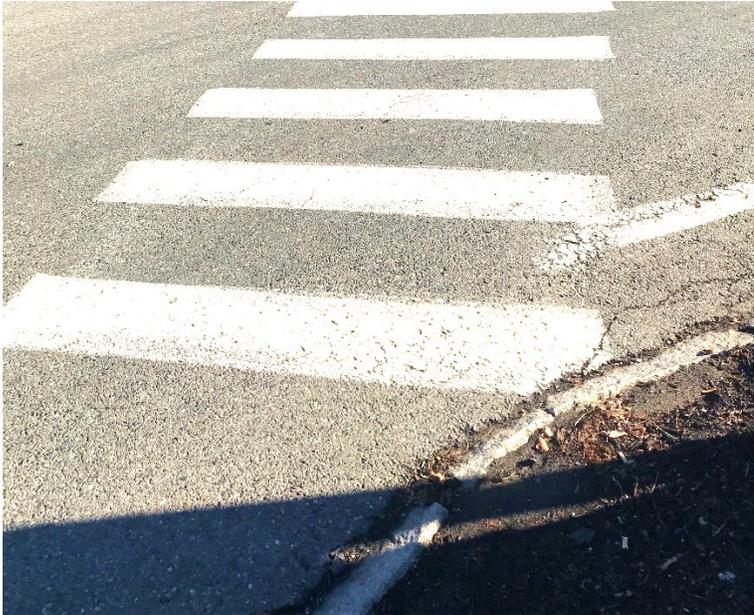
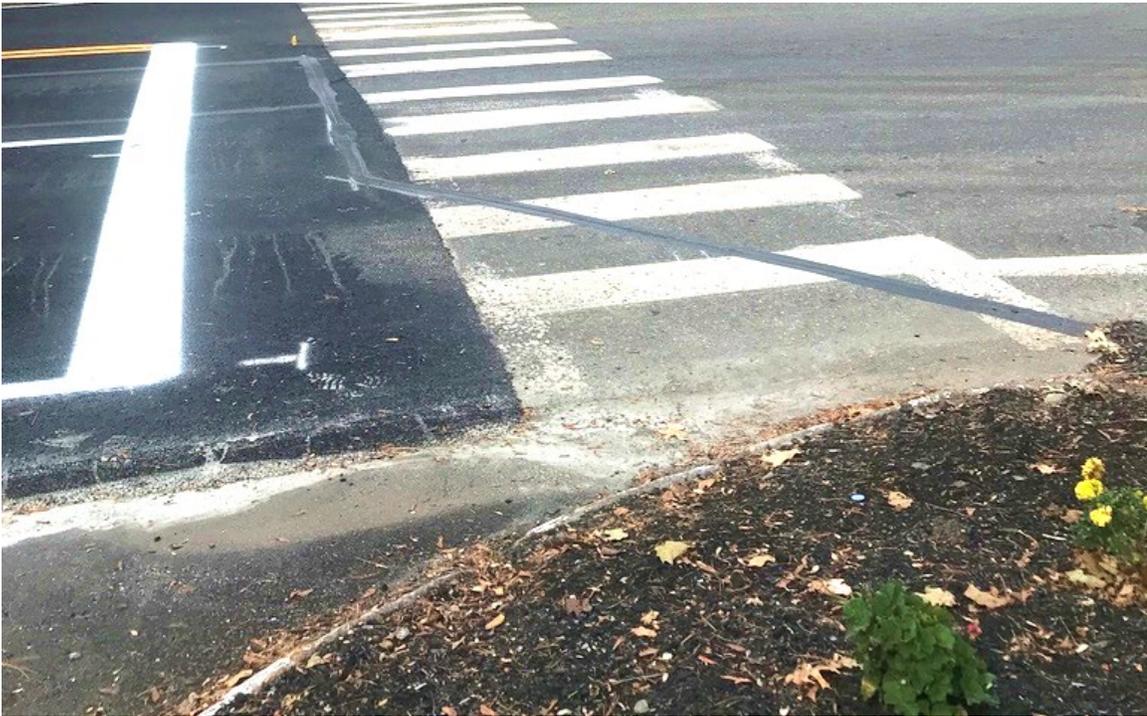
The intersection’s southwest corner does not include sidewalks, curb ramps, or detectable warning strips, but it does feature a crosswalk for both intersection legs. Both crosswalks lead directly into landscaping surrounded by a low curb.

Figure 10
View of Southwest Intersection Corner

Figure 11
View across Great Road (Route 117) of Southwest Intersection Corner

Figure 12
View across Gleasondale Road (Route 62) of Southwest Corner

Figure 13
Lack of Pedestrian Facilities on Southwest Intersection Corner leading to Gleasondale Road (Route 62) Crosswalk

Figure 14
Lack of Pedestrian Facilities on Southwest Intersection Corner leading to Great Road (Route 117) Crosswalk

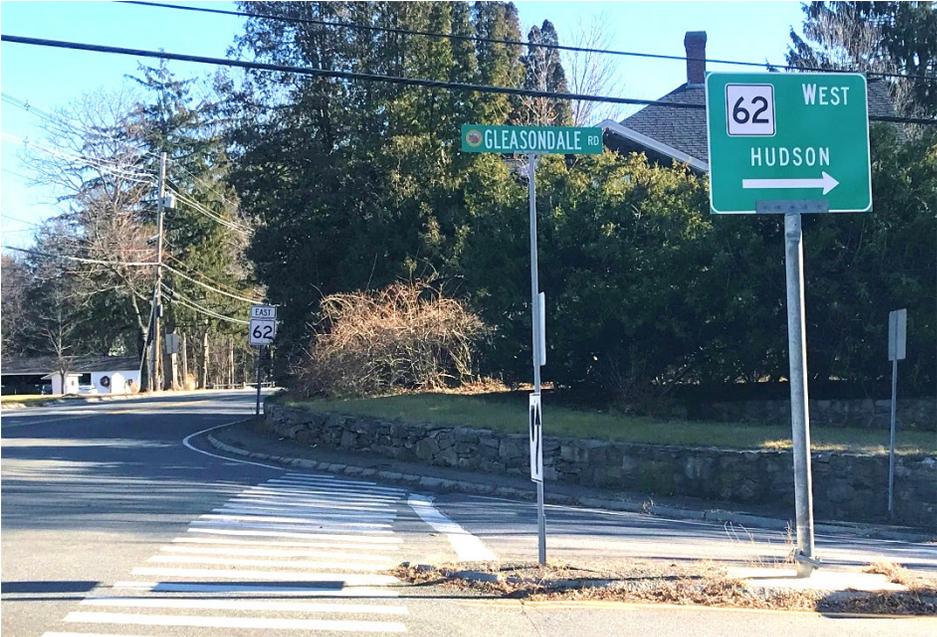
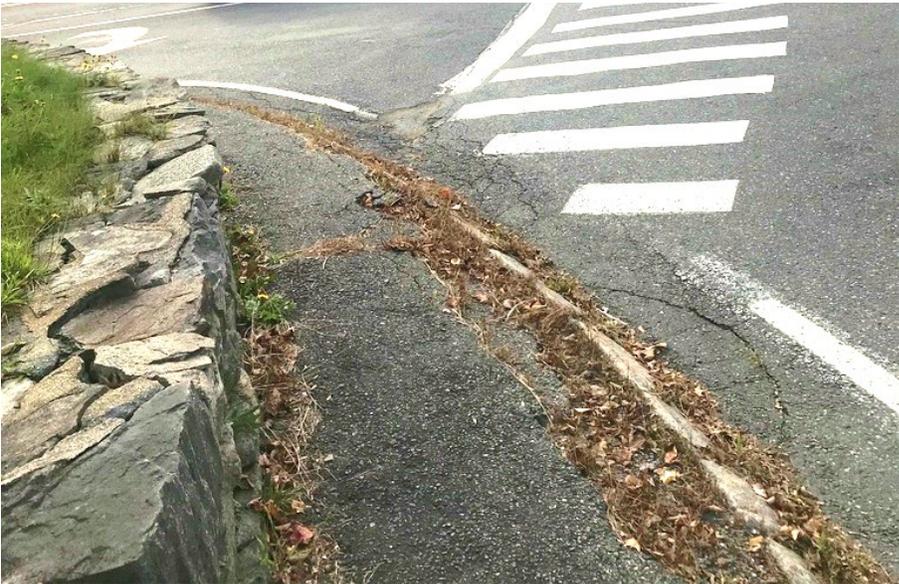
Finally, the southeast corner of the intersection features a narrow sidewalk with a steep curb that does not include curb ramps or pedestrian detectable warning strips. A crosswalk leads pedestrians across Gleasondale Road. There is no crosswalk to facilitate pedestrian travel across Great Road (Routes 117 and 62) to the northeast intersection corner.

Figure 15
View across Gleasondale Road (Route 62) of Southeast Intersection Corner

Figure 16
Southeast Intersection Corner Crosswalk Lacking Pedestrian Facilities

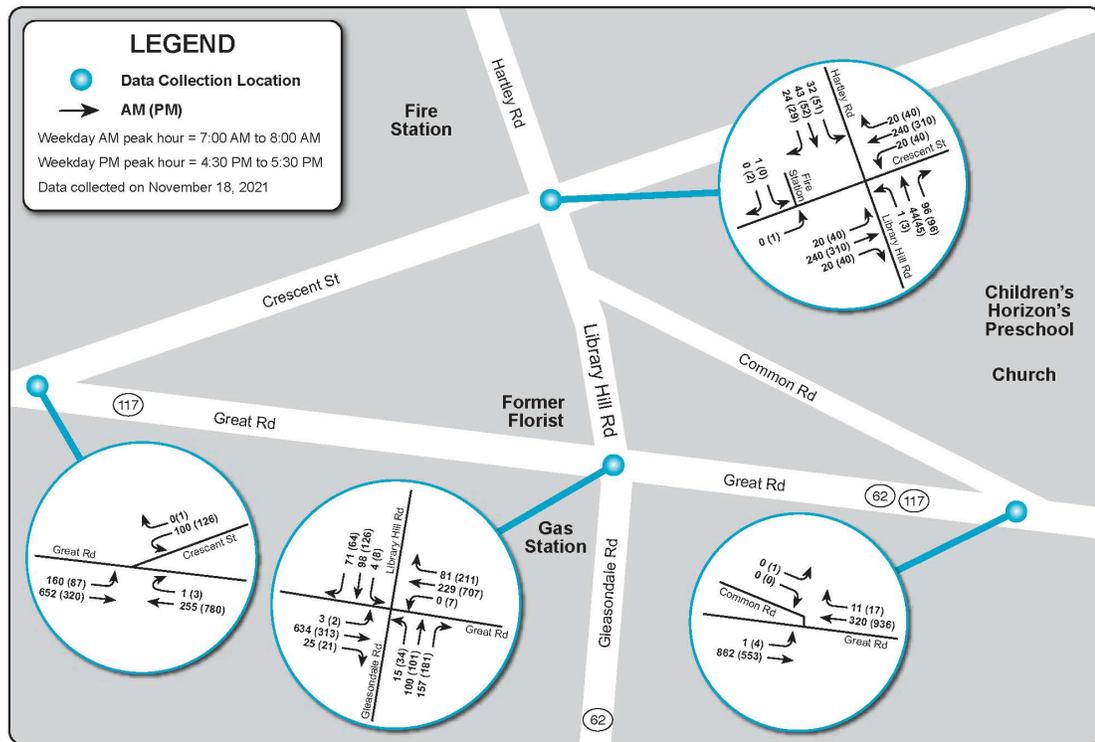
Figure 19
Peak Hour Turning Movement Volumes

Turning movement counts for the weekday AM and PM peak travel periods are illustrated in Figure 19.⁴ The total average number of vehicles that passed through the Route 117 and Route 62 (Great Road, Library Hill Road, and Gleasondale Road) intersection was 17,245 on weekdays and 12,794 on weekend days. The ATR counts are documented in Figure 20.

The intersection receives a greater amount of traffic during the AM peak than the PM peak travel period. The eastern branch of the intersection experiences the highest vehicle volumes during both peak periods, with the second-largest amount of traffic traveling along Great Road/Route 117 to the west of the intersection. The southern branch, Gleasondale Road/Route 62, is the third most traveled, and Library Hill Road, comprising the intersection’s northern branch, receives the lowest volumes.

While approximately 500 vehicles traveled northwest along Common Road during both peak periods (502 during the AM peak period and 469 during the PM peak period), only one vehicle was recorded traveling southeast along the roadway. This motorist turned left onto Great Road/Route 117/Route 62 to travel eastbound.

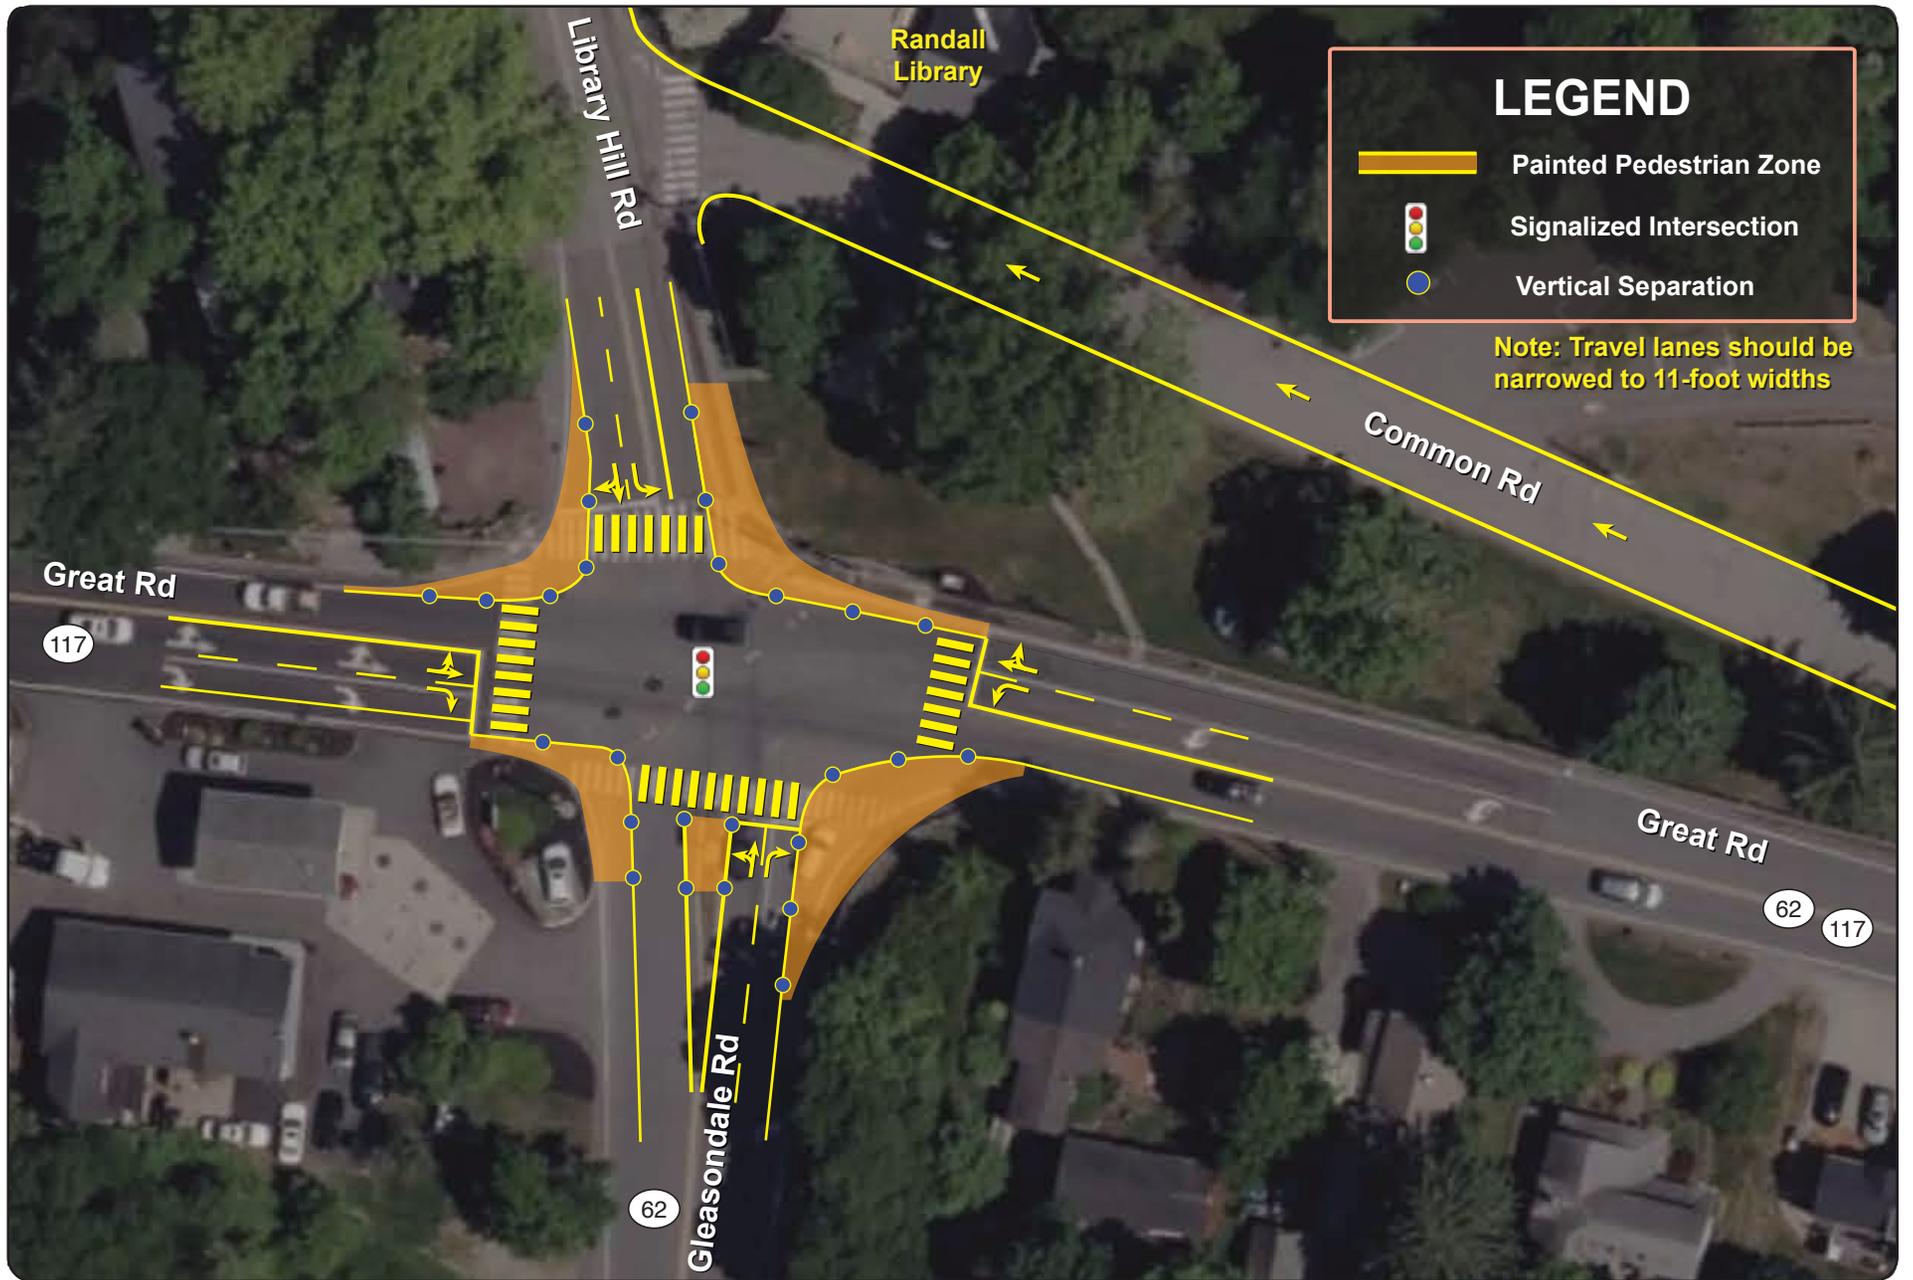
FIGURE 21
Proposed Short-Term Improvements
Routes 117 and 62, Stow MA

Listed below are additional low-cost, quickly implementable changes that Stow could make to the study intersection to improve safety. These recommendations are illustrated in Figure 21.

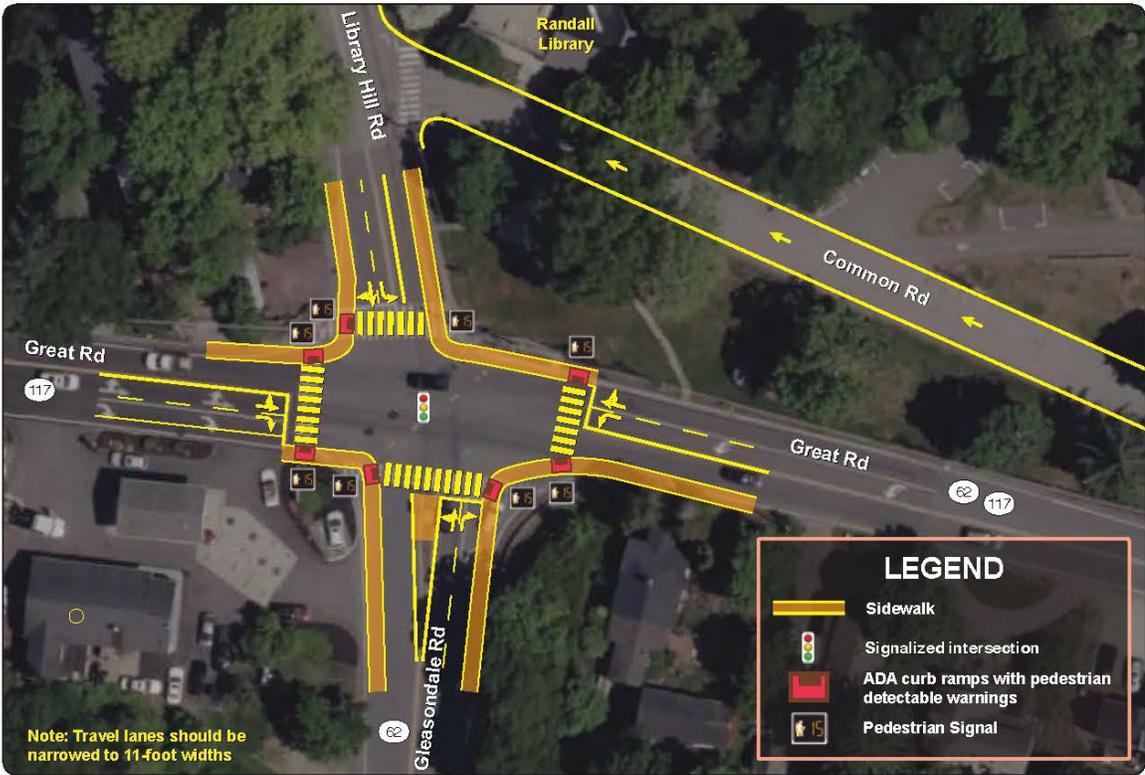
Figure 22
Recommended Future Investments

There are several investments in pedestrian travel that the Town of Stow could make to improve safety at the intersection of Route 117 and Route 62 (Great Road, Library Hill Road, and Gleasondale Road). As shown in Figure 22, these include the construction of proper sidewalks at least five feet in width along all intersection legs, adding curb ramps with pedestrian detectable warning strips where the sidewalk meets each intersection crosswalk, and installing audible, vibrotactile pedestrian signals with countdown timer displays.

This last investment would require adding a pedestrian crossing phase to the existing traffic signals to allow people who are walking to safely cross the intersection. The intersection’s longest current crossing is Gleasondale Road at the southern approach with a width of approximately 90 feet. It is recommended to allow pedestrians to travel at a pace of 3.5 feet per second, so the duration of the intersection’s pedestrian phase should last at least 25.7 seconds. Table 6 documents the optimized signal timings and LOS for the study intersection if a 26 second pedestrian phase is added to the signal cycle. This duration could be shortened if the Town of Stow narrows travel lane widths and creates larger pedestrian zones, reducing the distance that pedestrians need to cross.
