# lynnfield

## STUDY AREA

The study area for Lynnfield (shown in Figure 23) includes:

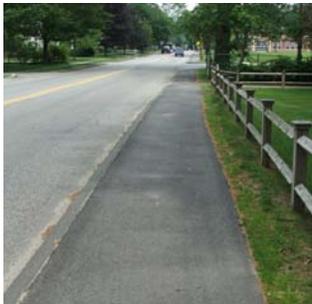
side along most of their lengths. The sidewalks are made of asphalt and are generally smooth; however, there are several sections that have bumps, cracks, and patches that could significantly impact pedestrian safety. See Figure 24 for a map of the pedestrian network in Lynnfield Center.

Lynnfield Center has a comprehensive sidewalk network.

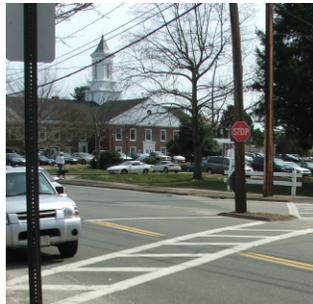
Crosswalks in Lynnfield Center have sufficiently visible pavement markings.

The majority of crosswalks in Lynnfield Center are visible to motorists and pedestrians and connect sidewalks across roadways in logical places. Most have curb cut ramps connecting them to the sidewalks. There are several signs identifying the crosswalks to motorists, particularly near the schools. See Figure 24 for a map of the pedestrian network in Lynnfield Center.

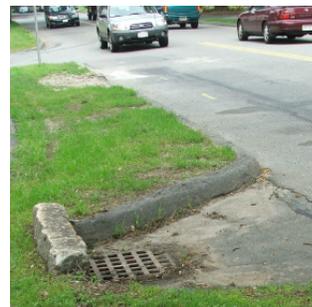
Drainage grates are set back from the roadway.

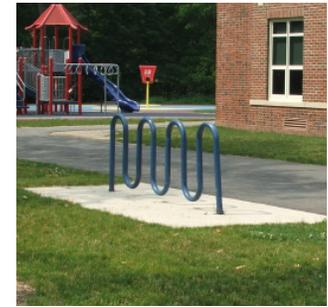
The Summer Street School has a bicycle rack.

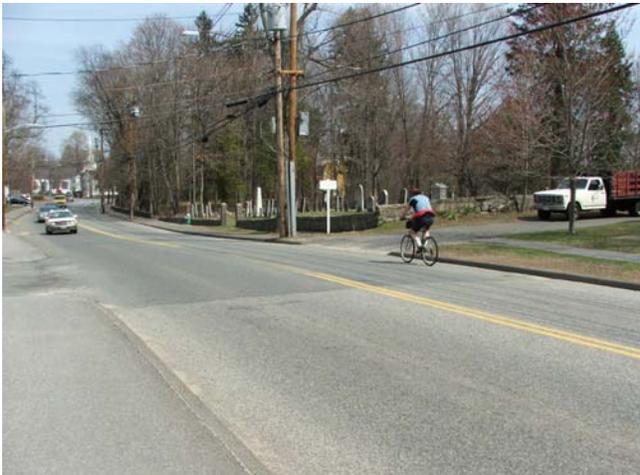
*Main Street, looking northeast*

The roadway's two travel lanes each range in width from 14 to 17 feet. The posted speed limit is 25 mph in both directions. The travel lanes are divided by a double solid yellow line. The roadway surface is smooth, with a few sections of small bumps, cracks, and patches. The edge of the roadway is relatively clear of obstructions, and most drainage grates are set back from the roadway. There are no marked bicycle lanes or shoulders. See Figure 25 for more details on bicycle conditions.

There are sidewalks on both sides of Main Street in this corridor. The sidewalks are made of asphalt and are generally smooth. At several locations, however, tree roots and sand make the sidewalk uneven (see Figure 25 for more details on sidewalk conditions). There are grass buffers between the sidewalk and roadway throughout much of the corridor, ranging in width from 2 feet to 9 feet. The asphalt sidewalk slopes down to the level of intersecting roadways. Driveways are raised to meet the level of the sidewalk, eliminating the need for curb cut ramps at these locations.

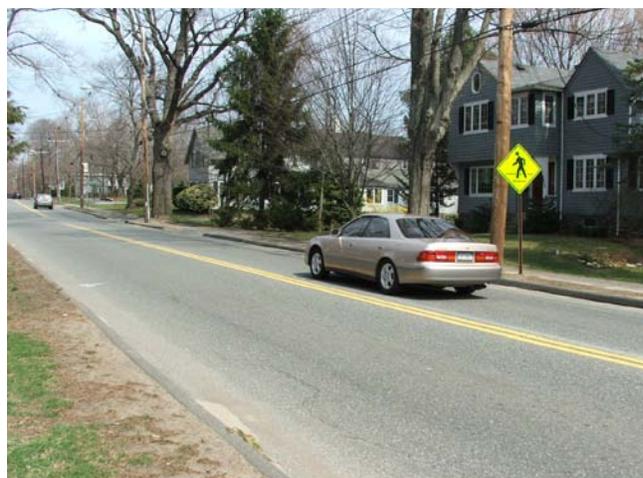
Main Street, looking northwest

The roadway's two travel lanes are each approximately 14 feet wide. The posted speed limit is 30 mph heading east from the town center, and 25 mph westbound. The travel lanes are divided by a double solid yellow line. The roadway surface is smooth, with a few sections of small bumps, cracks, and patches, mostly at the edge of the roadway. Many of the drainage grates are set back from the roadway. There are no marked bicycle lanes or shoulders. See Figure 25 for more information on bicycle conditions.

Street continues from the town center to beyond Essex Street. The sidewalks are made of asphalt and have impediments that could significantly impact the safety of pedestrians. At several locations, large tree roots and sand make the sidewalk very uneven (see Figure 25 for more details on sidewalk conditions). The sidewalks have grass buffers ranging in width from 2 feet to 7 feet. The asphalt sidewalk slopes down to the level of intersecting roadways. Driveways are raised to meet the level of the sidewalk, eliminating the need for curb cut ramps at these locations.

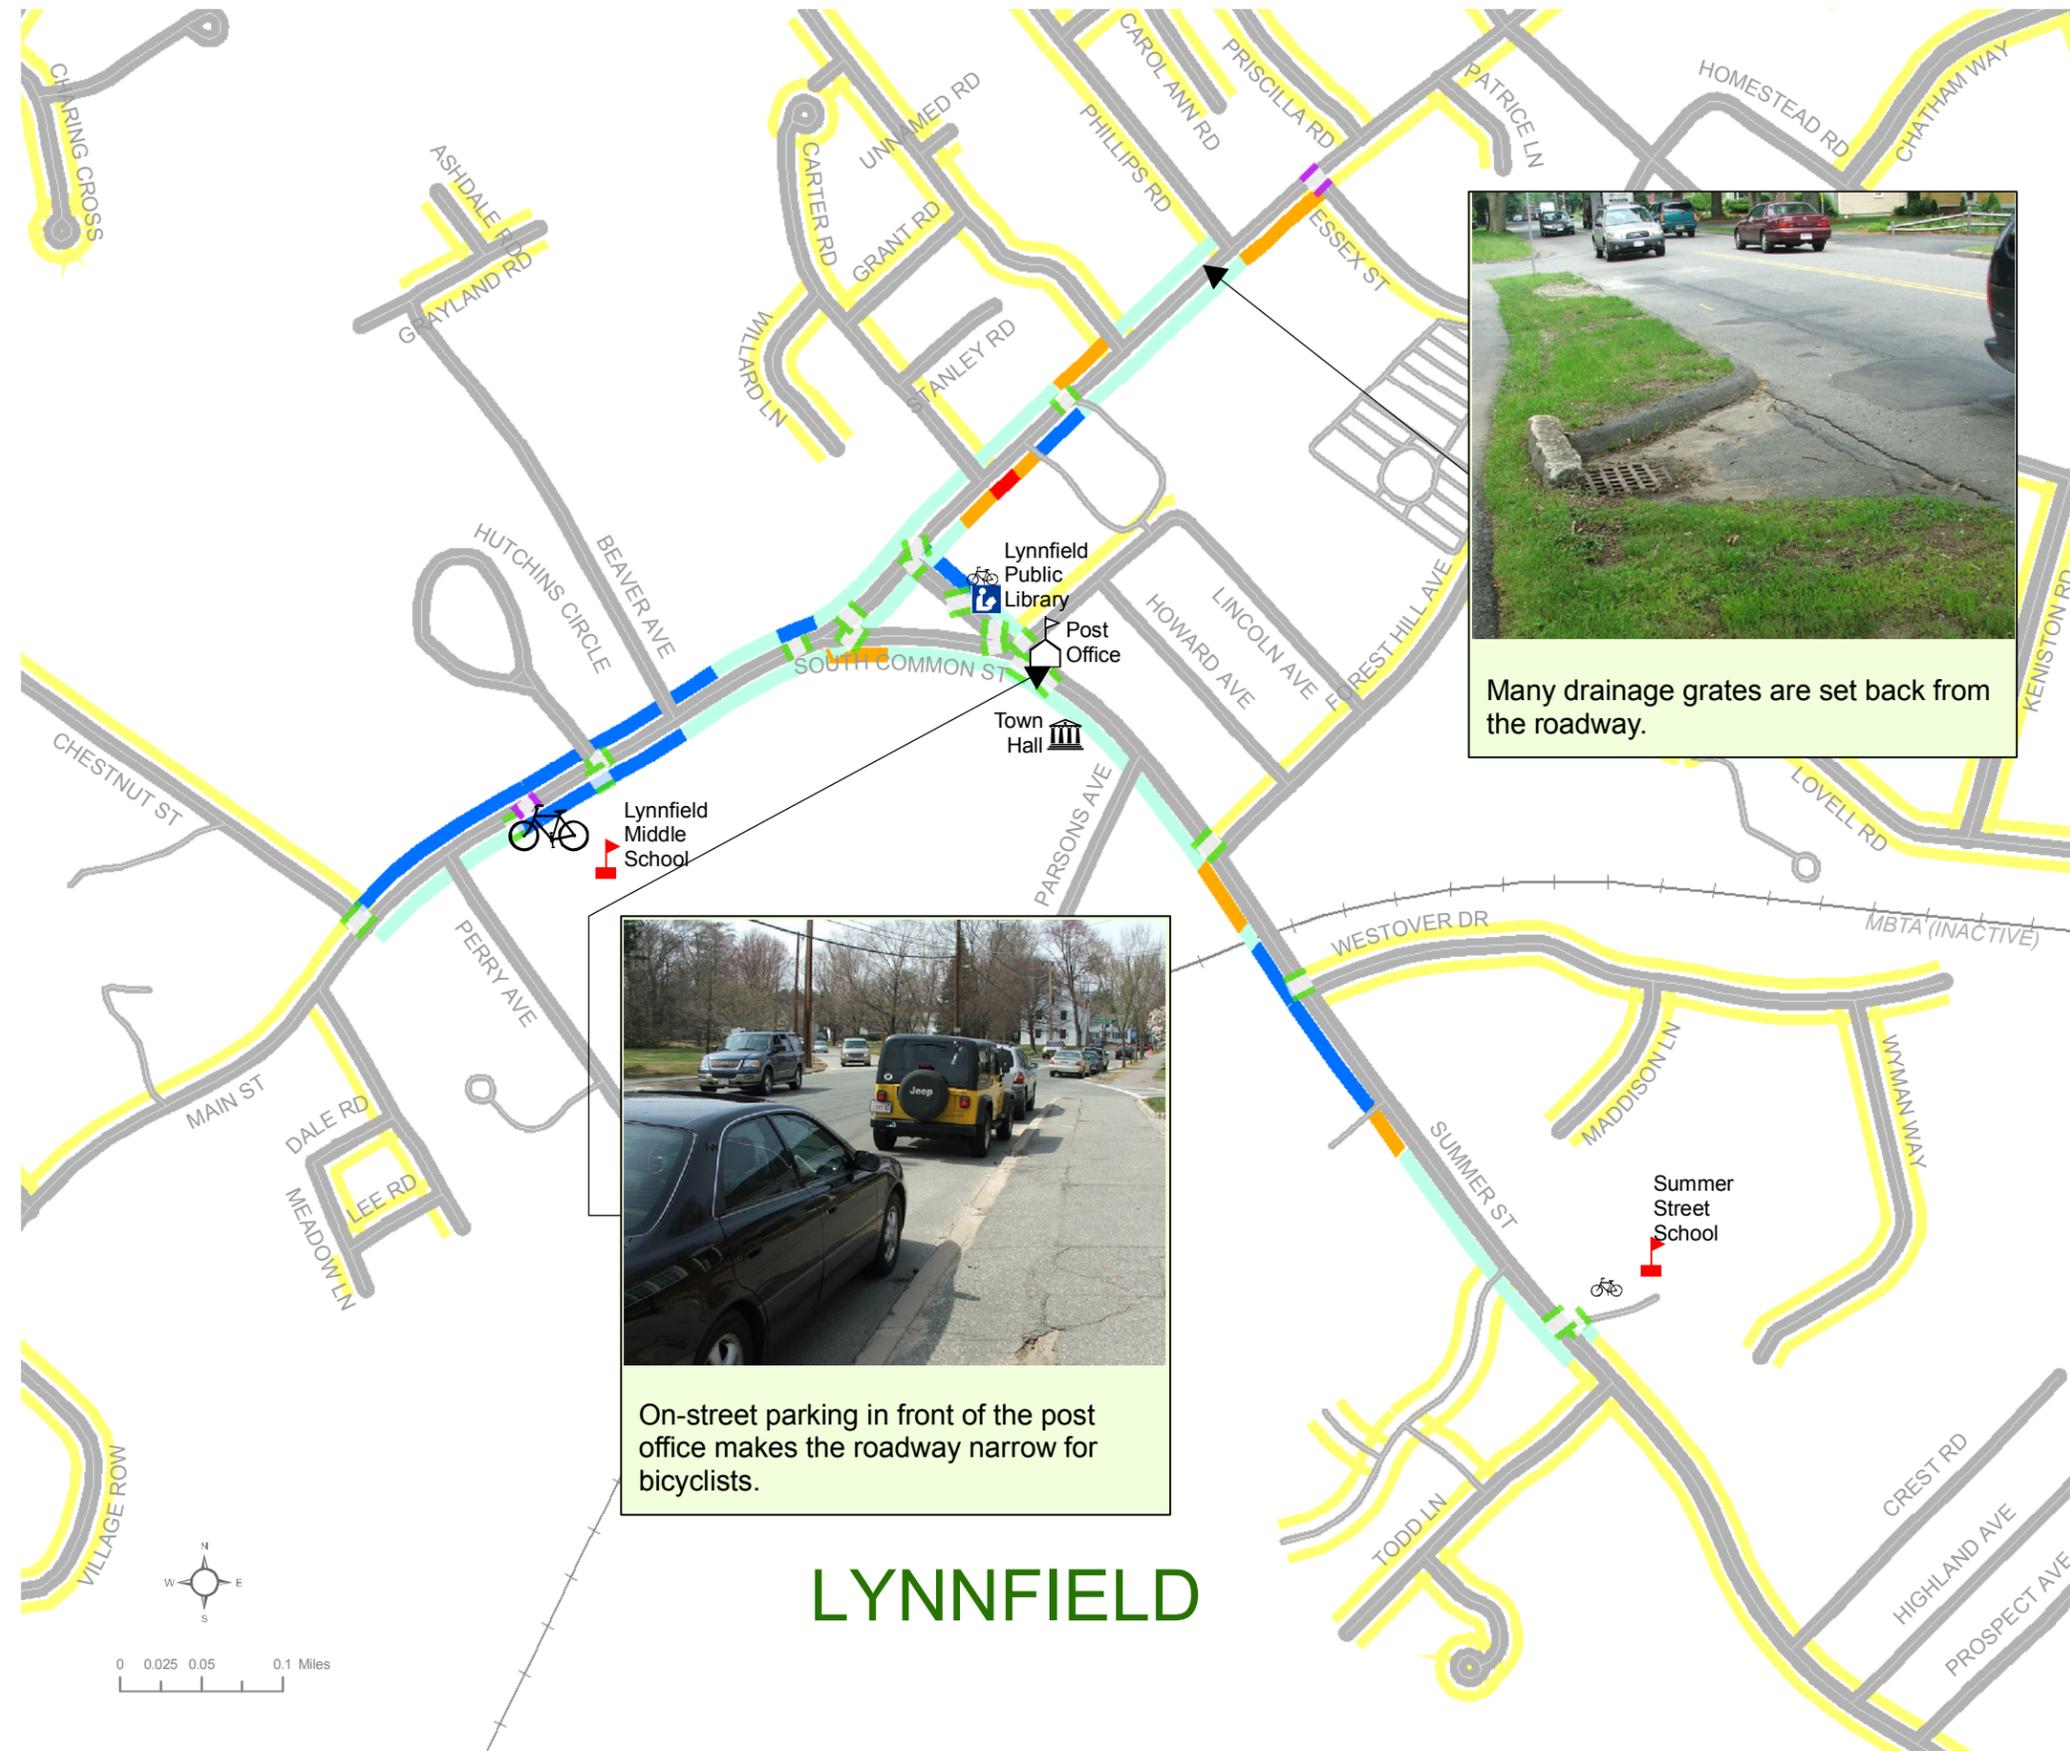
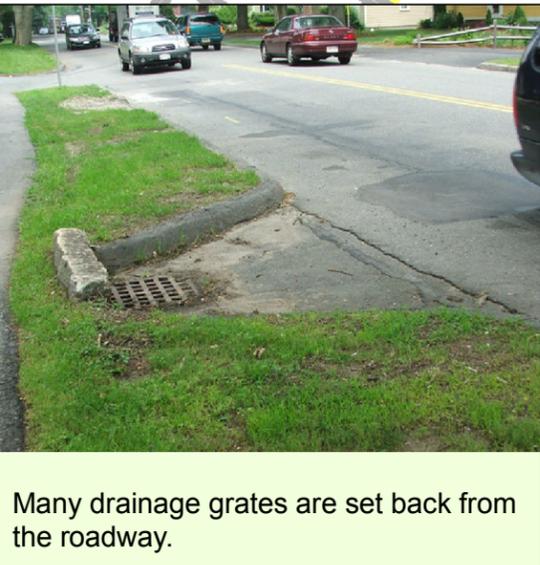
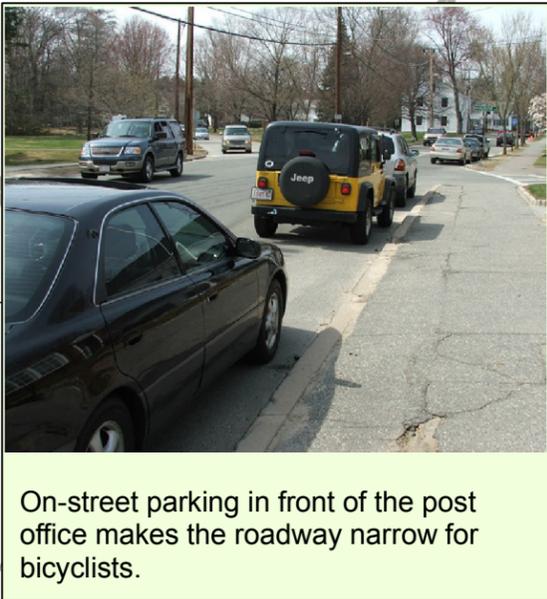
**FIGURE 25**  
**Pedestrian and Bicycle Network: Conditions**  
**Lynnfield**

Each of these crosswalks has sufficiently visible or moderately faded pavement markings (see Figure 25 for more details on crosswalk conditions). There are no crosswalks across the three driveways at The Centre at Lynnfield shopping plaza at Main Street and across Perry Avenue at Main Street. The existing crosswalk across Main Street just east of the Lynnfield Middle School parking lot lacks curb cut ramps connecting the sidewalk to the crosswalk. On the north end of the crosswalk, there is a grass buffer between the crosswalk

Each of these crosswalks has sufficiently visible or moderately faded pavement markings (see Figure 25 for more details on crosswalk conditions). There are two sidewalks in the Center Village development that meet Main Street. Crosswalks could be installed across Main Street to connect to these sidewalks. Doing so would eliminate the need for the existing crosswalk across Main Street at Center Village. The sidewalk that crosses Main Street at Summer Streets lacks a curb cut ramp on its south side.

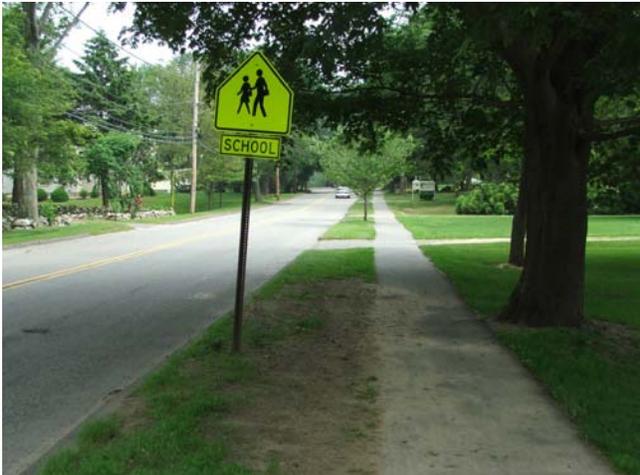
*Summer Street, looking southwest*

The roadway's two travel lanes are each approximately 15 feet wide. There are on-street parking spaces along the east side of Summer Street from the post office to Main Street and on the west side of the street opposite the post office. None of these parking spaces have pavement markings. The posted speed limit is 35 mph heading south from the town center and 20 mph as you approach Lynnfield Center from the south. The travel lanes are divided by a double solid yellow line. The roadway surface is smooth, with sections of bumps, cracks, and patches, mostly at the edge of the roadway. Many of the drainage grates are set back from the roadway so as not to obstruct the roadway. There are no marked bicycle lanes or shoulders. The roadway's edge is relatively clear of debris that could be hazardous to bicyclists. See Figure 25 for more details on bicycle conditions.

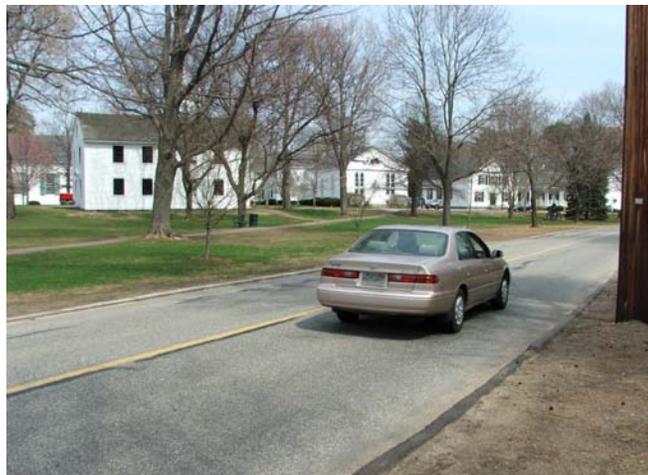
*South Common Street, looking east*

The roadway's two travel lanes are each approximately 11.5 feet wide. The speed limit is not posted along this corridor. The travel lanes are divided by a single solid yellow line. The roadway surface is smooth, with a few cracks that do not pose a safety threat to bicyclists. The drainage grates are set back from the roadway so as not to obstruct the shoulder. There are no marked bicycle lanes or shoulders. The roadway edge is relatively clear of debris and other obstructions. See Figure 25 for more details on bicycle conditions.

There is a sidewalk on the west side of the street for the entire length of the roadway. The sidewalk ranges in width from 4.5 feet to 5.5 feet. It is made of asphalt and contains some impediments that may decrease pedestrian safety (see Figure 25 for more details on sidewalk conditions). There is a grass buffer between the sidewalk and the roadway. The sidewalk connects to the sidewalks along the south side of Main Street and the west side of Summer Street, but does not cross any driveways or roadways.

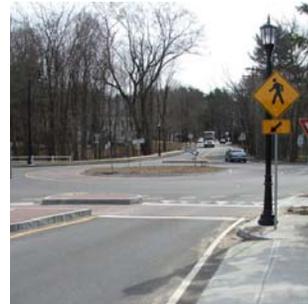
Two roundabouts were recently installed in the town center.

There is a roundabout at the intersection of Main Street, Rockwood Road, and Union Street. It was recently installed as part of the town-center roadway reconstruction project. There is a raised center island surrounded by a 10-foot brick buffer, allowing large trucks to traverse the roundabout safely, while guiding cars into the single travel lane at its perimeter.

The posted speed limit is 15 mph at each approach to the roundabout. There are crosswalks with median islands at each approach. Staff observed that motorists yielded for pedestrians in the crosswalks at the roundabout.

There is also a roundabout at the intersection of Liberty Lane/North Street and Union Street, which was also recently installed as part of the town center roadway reconstruction project. There is a raised center island surrounded by a 10-foot brick buffer, allowing large trucks to traverse the roundabout safely, while guiding cars into the single travel lane at its perimeter. The posted speed limit is 15 mph at each approach to the roundabout. There are crosswalks with median islands at the Liberty Lane and Union Street approaches to the roundabout. Staff observed that motorists yielded for pedestrians in the crosswalks at the roundabout.

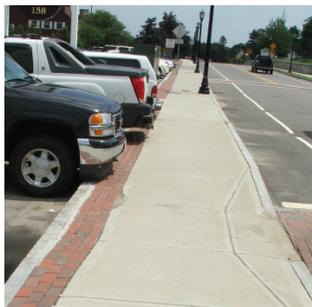
Most of the sidewalks in the town center have smooth surfaces.

Norfolk has a comprehensive sidewalk network in its town center. There are wide concrete sidewalks along Main Street, Liberty Lane, Independence Drive, and Union Street (between Main Street and North Street). These sidewalks were constructed as part

of the town center roadway reconstruction project mentioned earlier. Rockwood Road, Boardman Street, and North Street have sidewalks on only one side. These sidewalks are made of asphalt and have only a few bumps and cracks that are not likely to affect pedestrian safety. See Figure 28 for a map of the pedestrian network in Norfolk's town center.

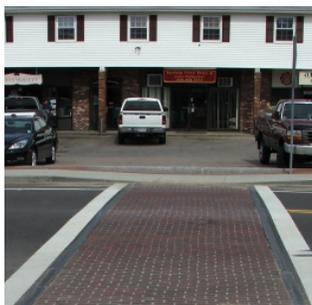
have brick surfaces with inlaid granite borders that are outlined with white paint. The crosswalks connect sidewalks across roadways with curb cut ramps in logical places. There are signs warning motorists about these crosswalks. Other crosswalks (along Rockwood Road and Boardman Street, for example) are marked only with paint and some have faded. (See Figure 28 for a map of the pedestrian network in Norfolk's town center.)

Norfolk's town center has brick crosswalks that are highly visible.

Norfolk's town center has an extensive crosswalk network connecting its sidewalks. Most of the crosswalks in the town center were reconstructed as part of the town center roadway reconstruction project. These crosswalks

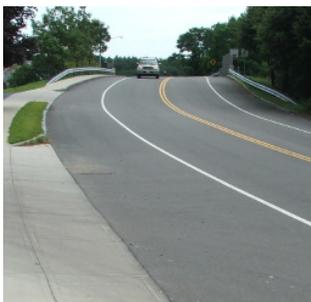
The shoulders along Main Street are wide enough to fully accommodate bicyclists.

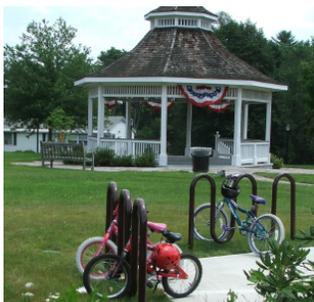
There are bicycle racks at the town hall, library, and commuter rail station.

- A bicycle rack with 6 spaces at the town hall
- A bicycle rack with 12 spaces at the Norfolk Public Library
- Three bicycle racks with 11 spaces at the Norfolk commuter rail station

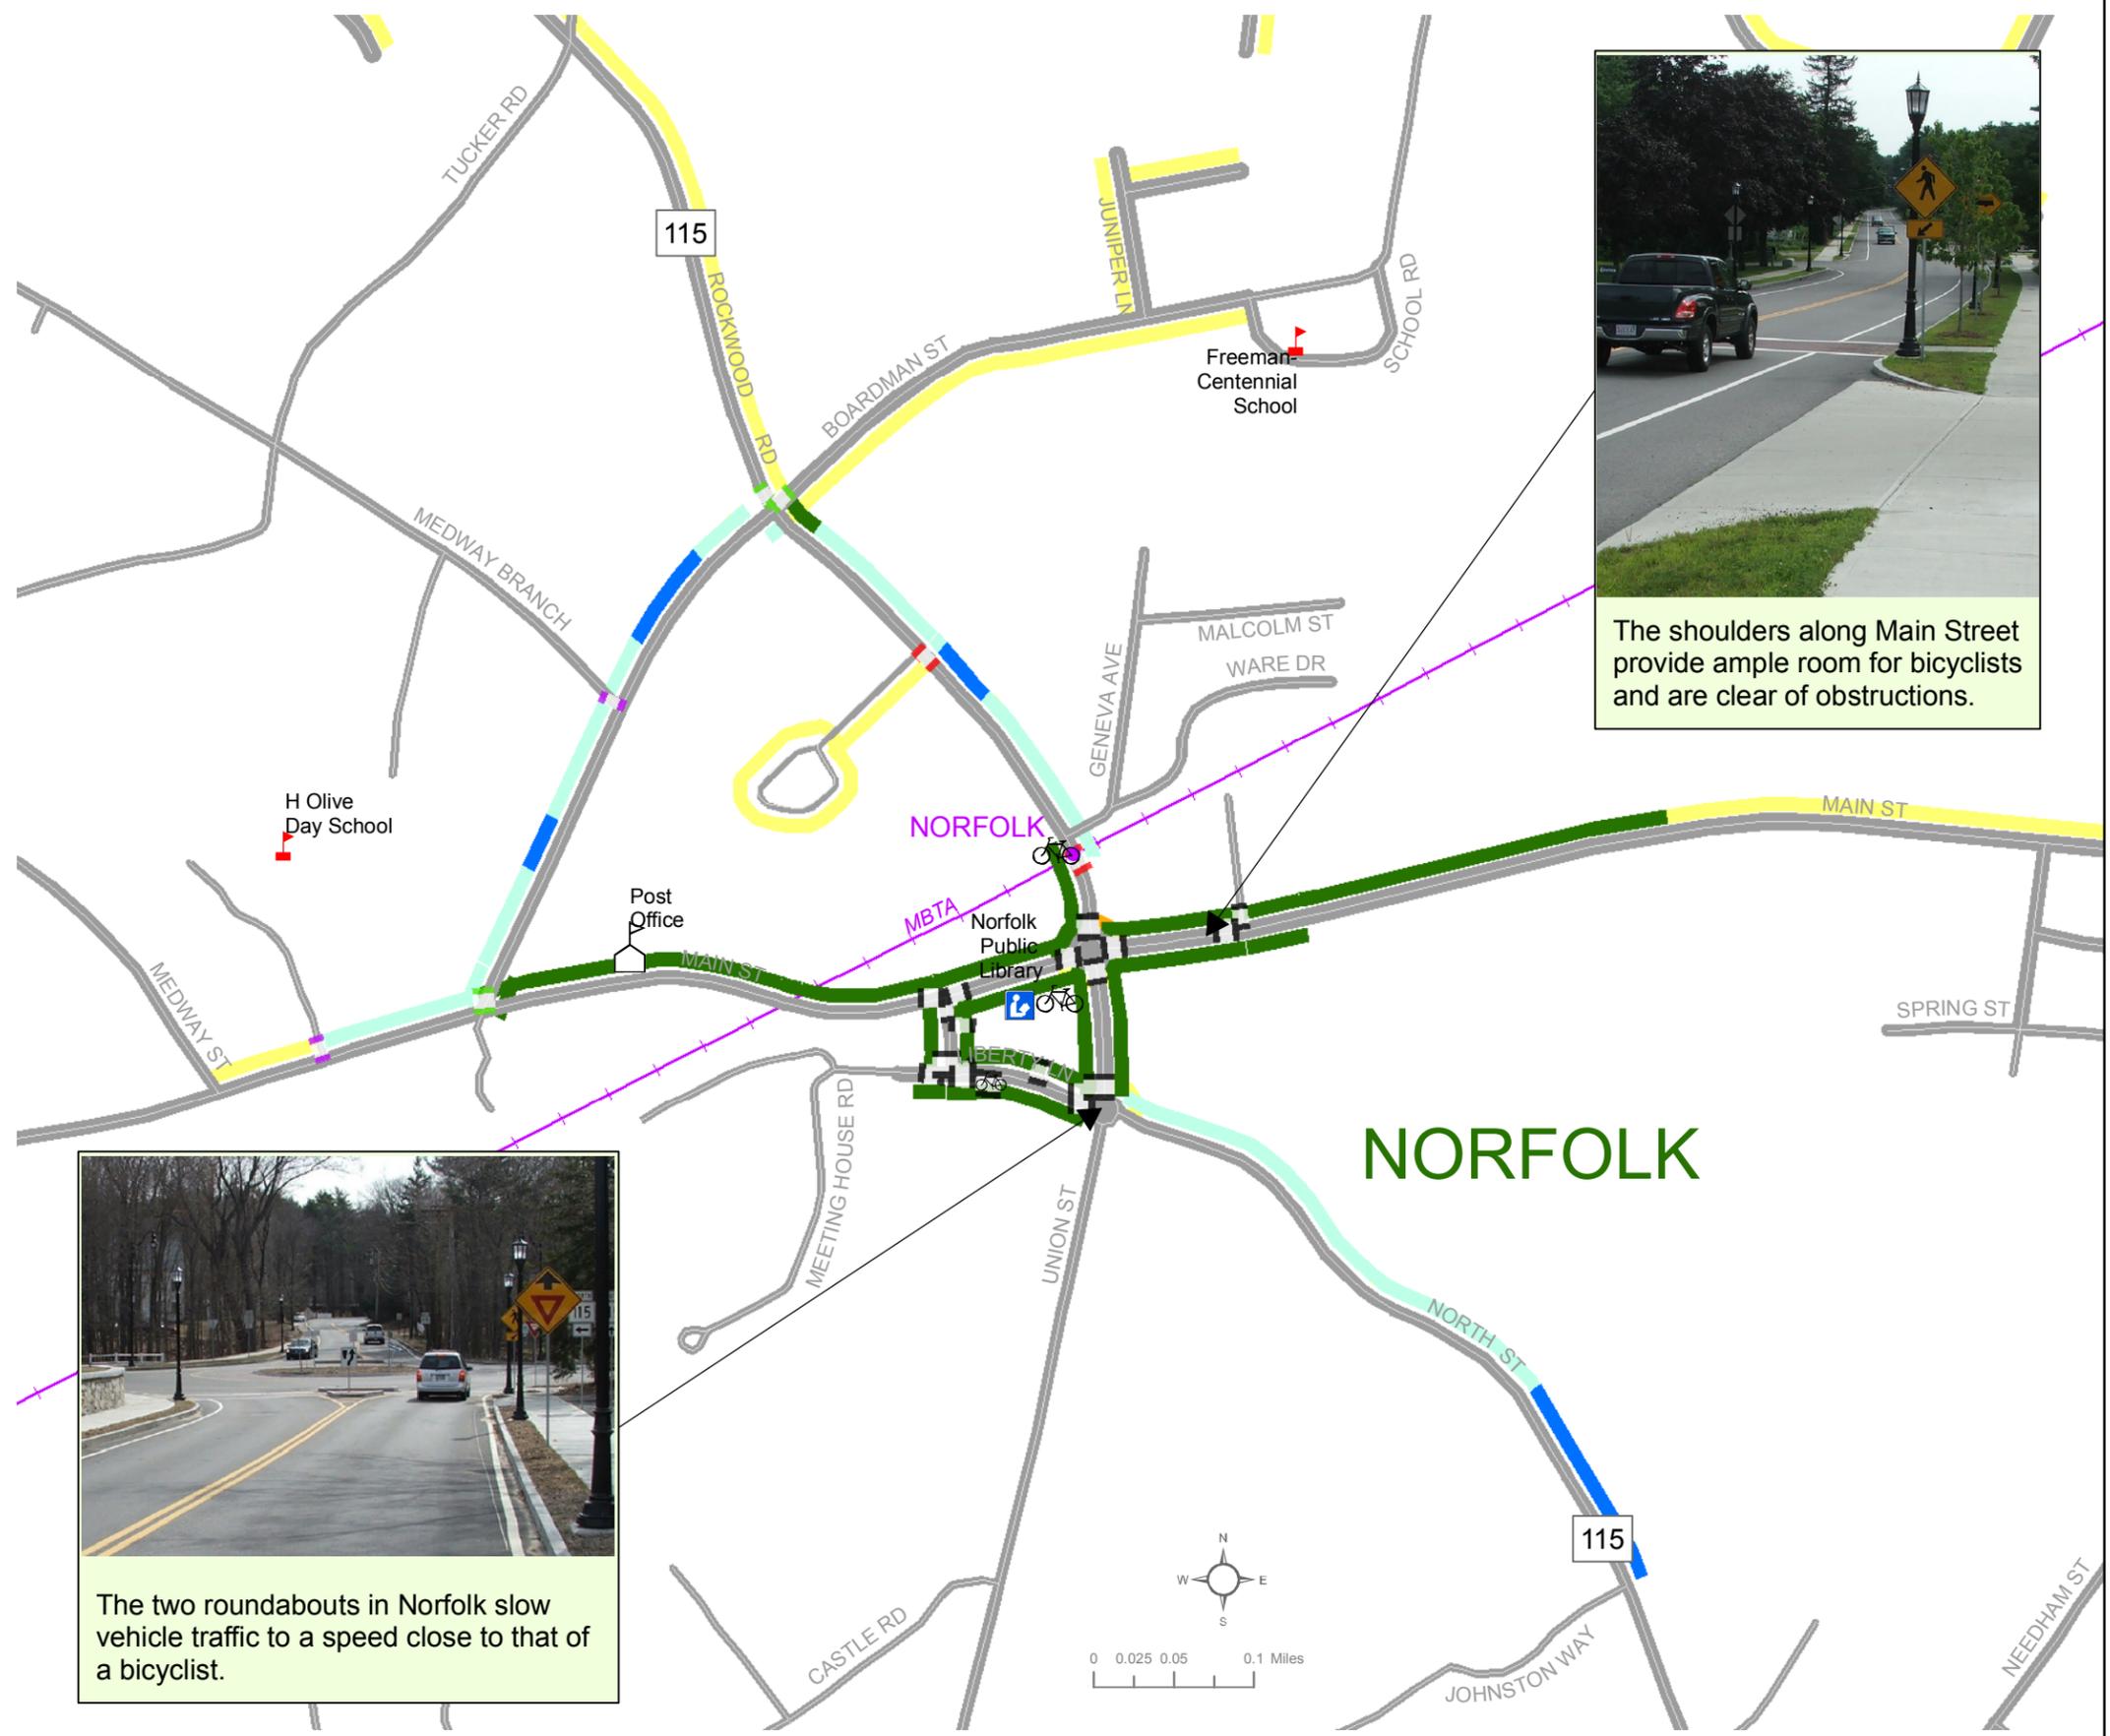
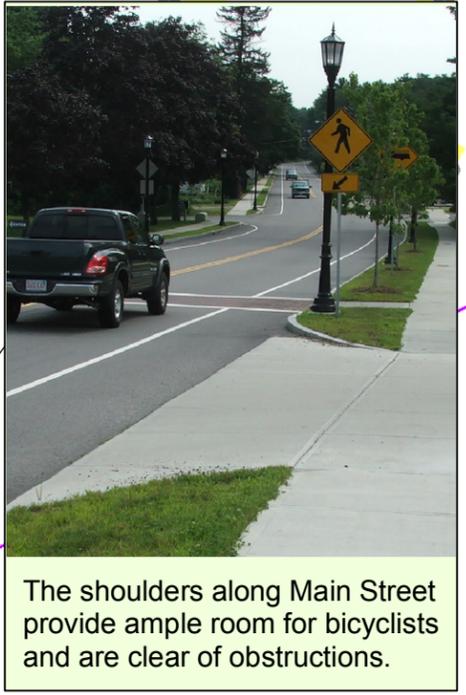
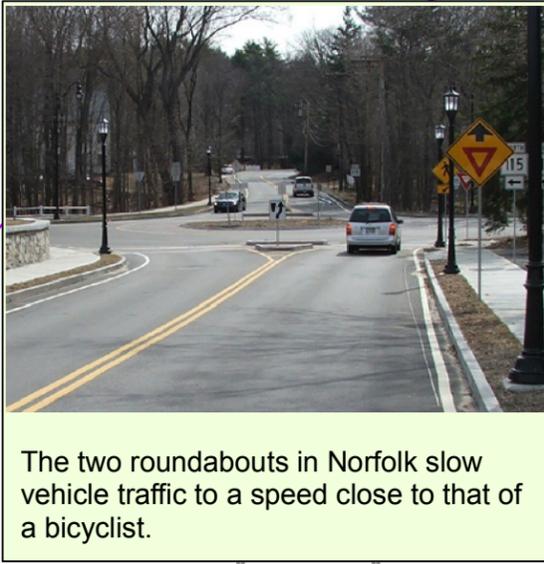
**FIGURE 29**  
**Pedestrian and Bicycle Network: Conditions**  
**Norfolk**

There is a concrete sidewalk along the south side of Main Street from Independence Drive to the police station. It is 5 feet wide, with a grass buffer that ranges in width from 2.25 feet to 5 feet. The sidewalk surface is smooth, with no impediments (see Figure 29 for more details on sidewalk conditions).

Each of these crosswalks has highly visible pavement markings (see Figure 29 for more details on crosswalk conditions). There is no stop sign on the commuter rail parking lot's exit-only driveway at the crosswalk along Main Street.

Each of these crosswalks has either sufficiently visible or very faded pavement markings (see Figure 29 for more details on crosswalk conditions). There are no crosswalks across Ware Drive, the gas station driveway, or the driveway at the commuter rail parking lot at Rockwood Road. The very faded crosswalk across Rockwood Road at the commuter rail station is striped at a sharp angle to the roadway. Installing signs warning drivers about the crosswalks across Rockwood Road at Hillcrest Village and the Norfolk commuter rail station could improve pedestrian safety.

There are sidewalks on both sides of the street along Union Street between Main Street and North Street/Liberty Lane. The sidewalks are 5 feet wide; they are made of concrete and are smooth, with no impediments to pedestrians (see Figure 29 for more details on sidewalk conditions). There are 2-foot-wide grass buffers on each side of the road, except in front of the church, where on-street parking spaces replace the grass buffer. The concrete sidewalks continue across driveways and dip slightly. There are curb cut ramps where the sidewalk meets intersecting roadways or driveways. Driveways are slightly raised to reduce the slope of the curb cut ramps. There are no sidewalks along Union Street south of North Street/Liberty Lane.

These crosswalks have highly visible pavement markings (see Figure 29 for more details on crosswalk conditions).

This crosswalk has very faded pavement markings (see Figure 29 for more details on crosswalk conditions).

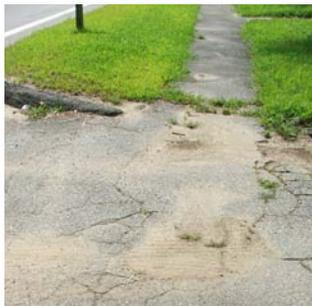
Some sidewalks are narrow and uneven.

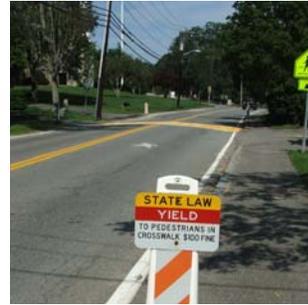
Several signs alert motorists to this crosswalk across Main Street.

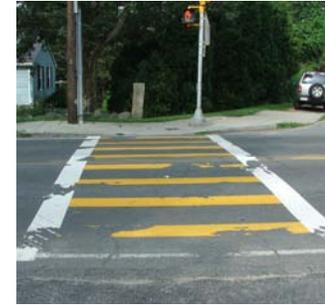
Signalized pedestrian crosswalk across Marlboro Road

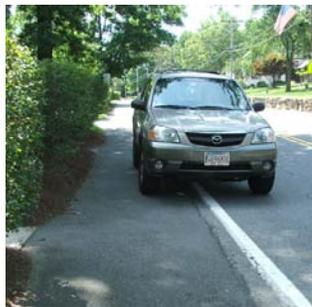
eral vehicles parked on sidewalks and on the shoulders along Main Street, creating dangerous conditions for bicyclists. See Figure 32 for more details on bicycling conditions in Southborough Center.

*Car parked on the sidewalk and on the shoulder along Main Street*

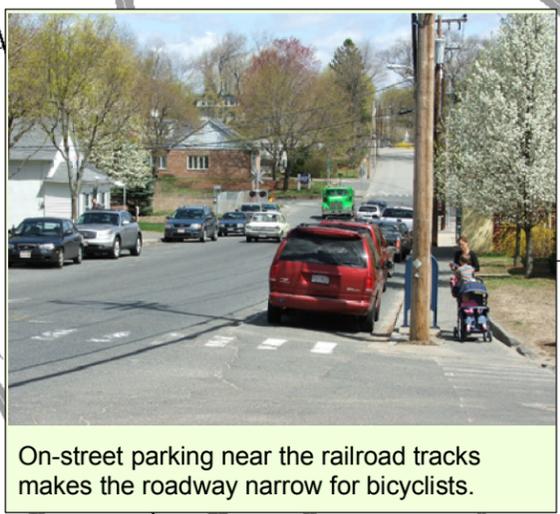
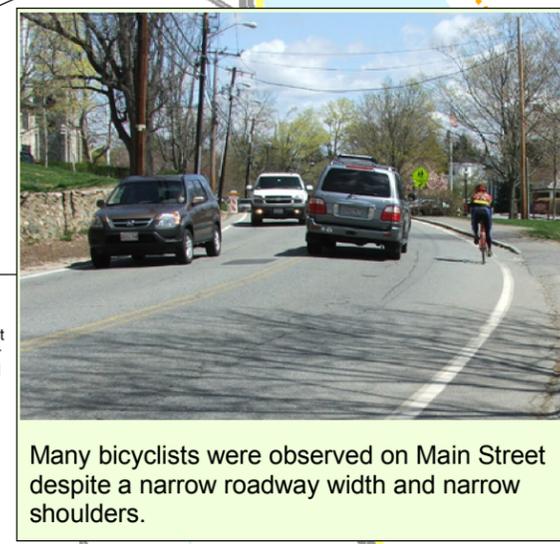
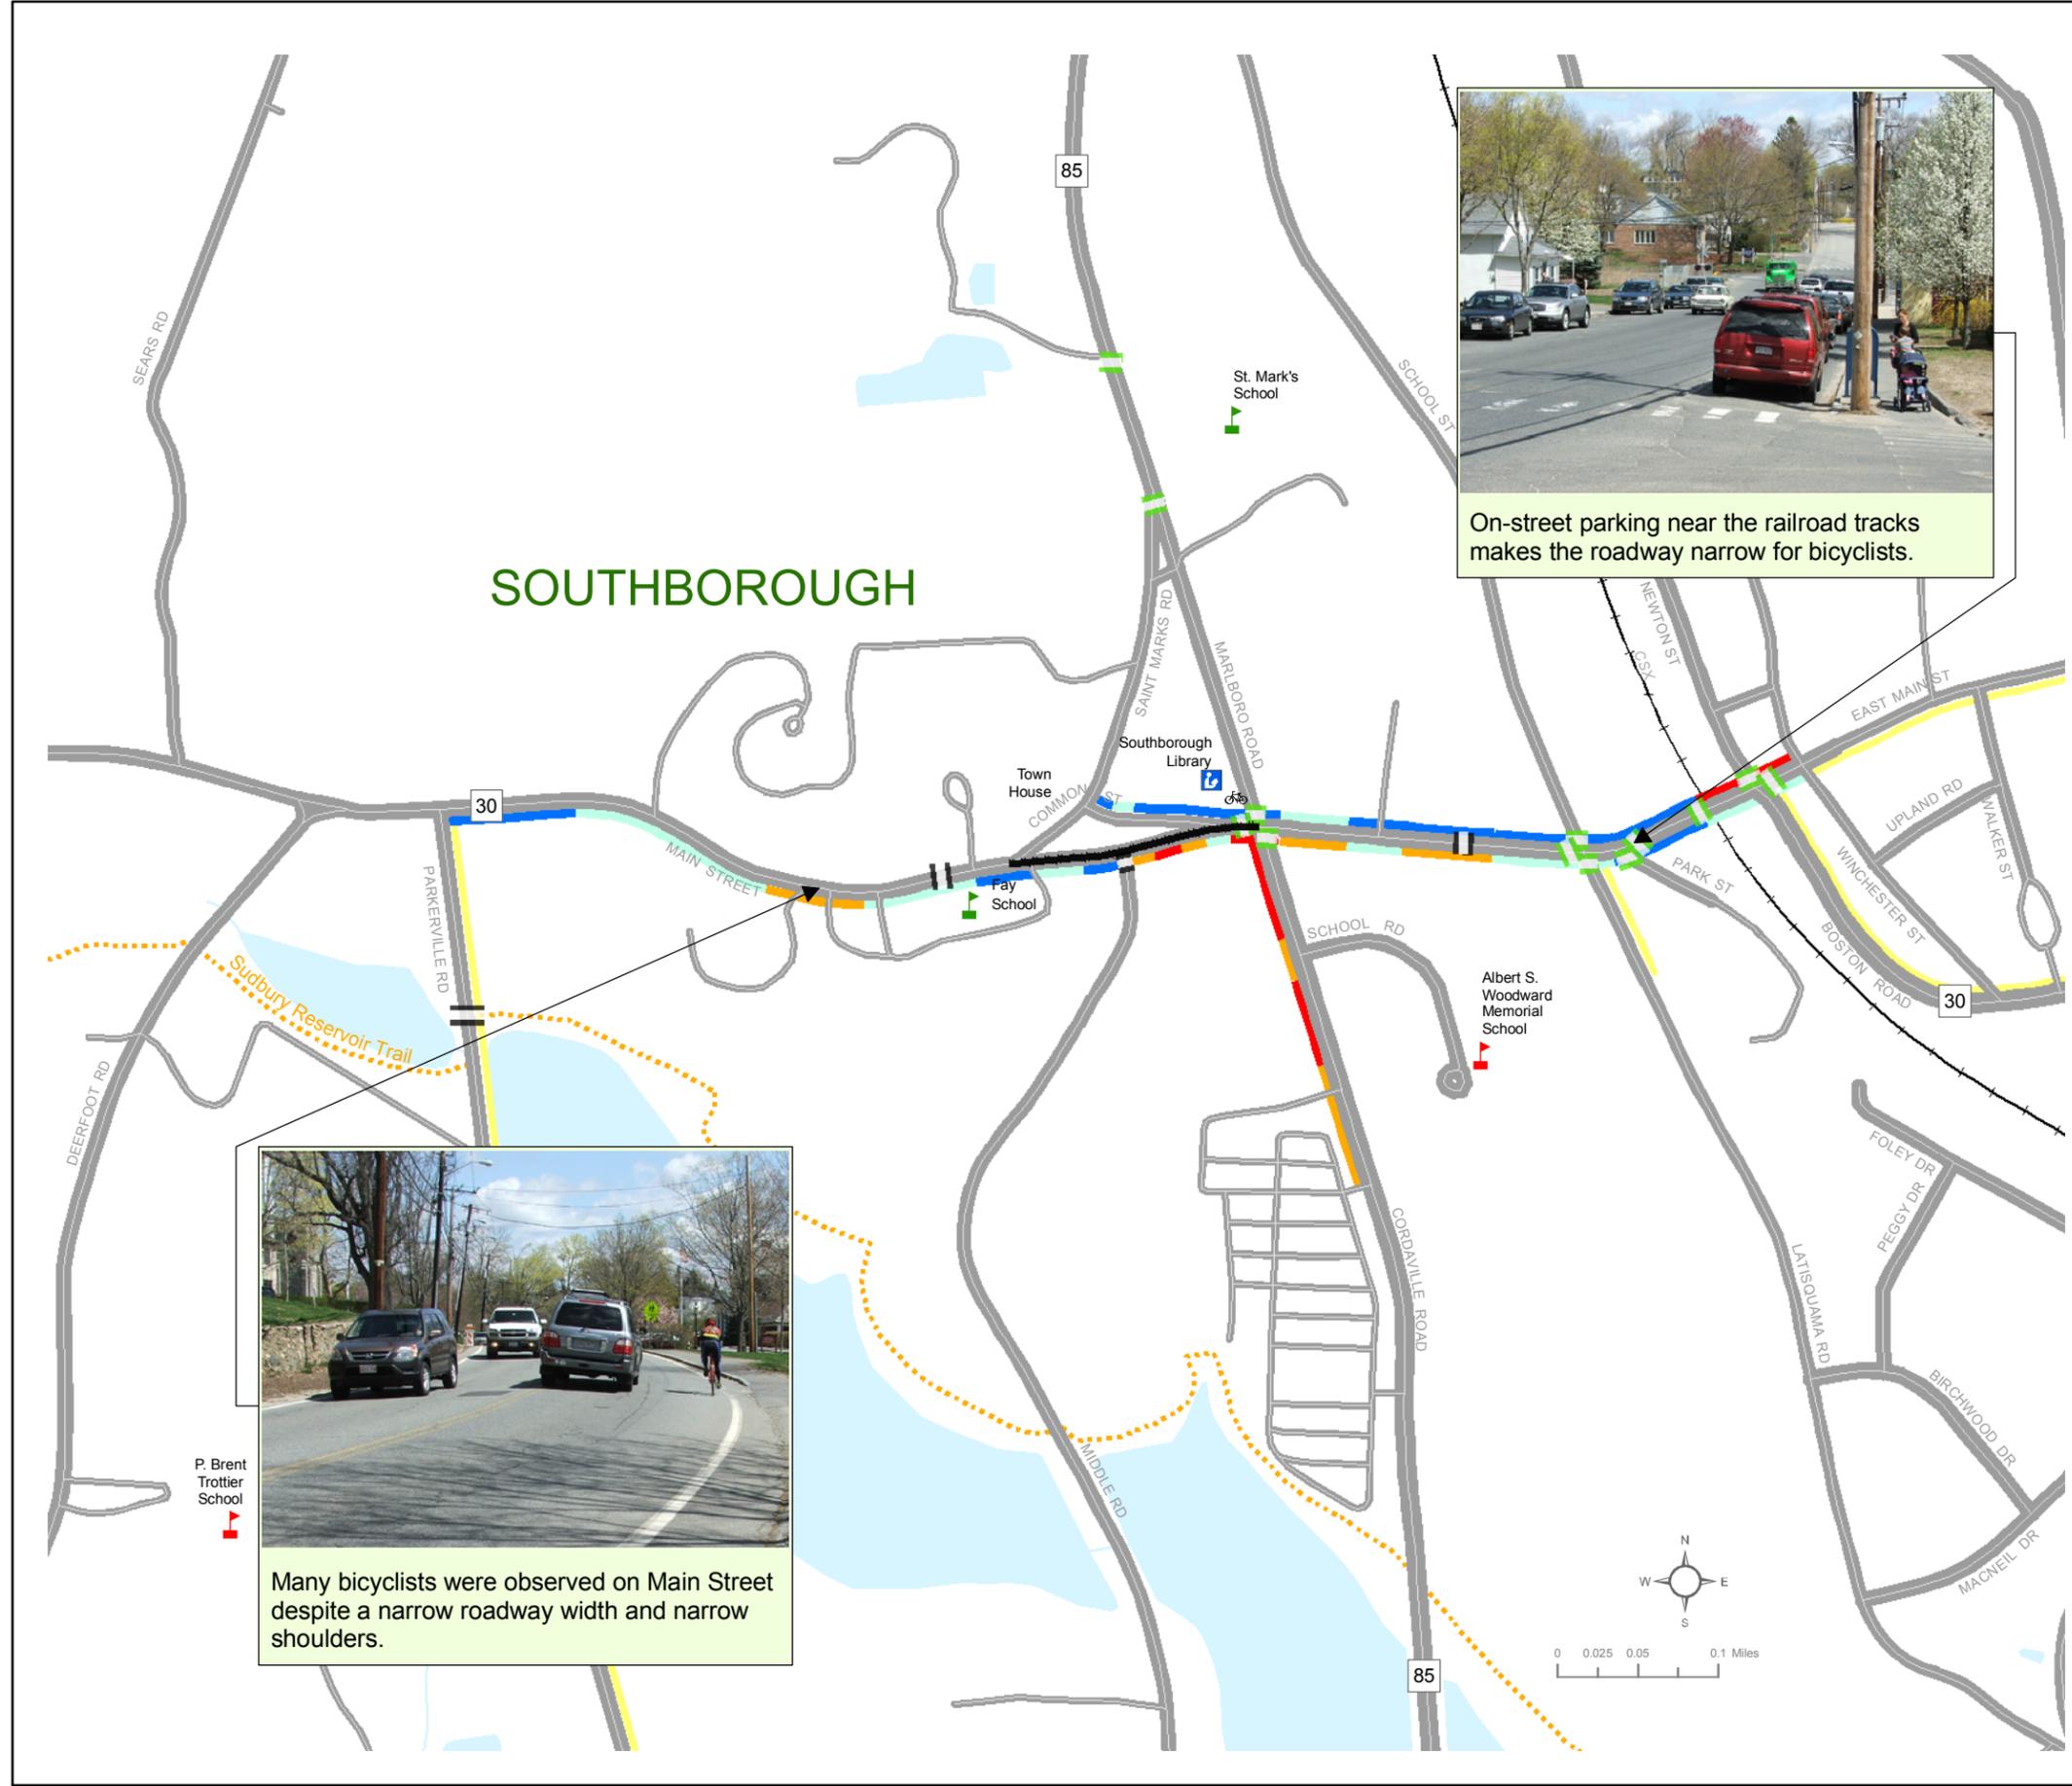
**FIGURE 33**  
**Pedestrian and Bicycle Network: Conditions**  
**Southborough**

limit. The travel lanes are divided by a double solid yellow line, and solid white lines delineate the shoulders. The roadway surface is smooth, with some minor cracks that do not significantly affect bicyclist safety. The edge of the roadway is clear of obstructions that would impact bicyclist safety. There is a comb-style bicycle rack at the library that can accommodate five bicycles. See Figure 33 for more details on bicycling conditions.
