## BOSTON REGION METROPOLITAN PLANNING ORGANIZATION

### MEMORANDUM

**DATE** December 6, 2012  
**TO** Boston Region Metropolitan Planning Organization  
**FROM** Mark Abbott and Christine Bettin  
MPO Staff  
**RE** Safe Access to Transit for Pedestrians and Bicyclists: Braintree Station

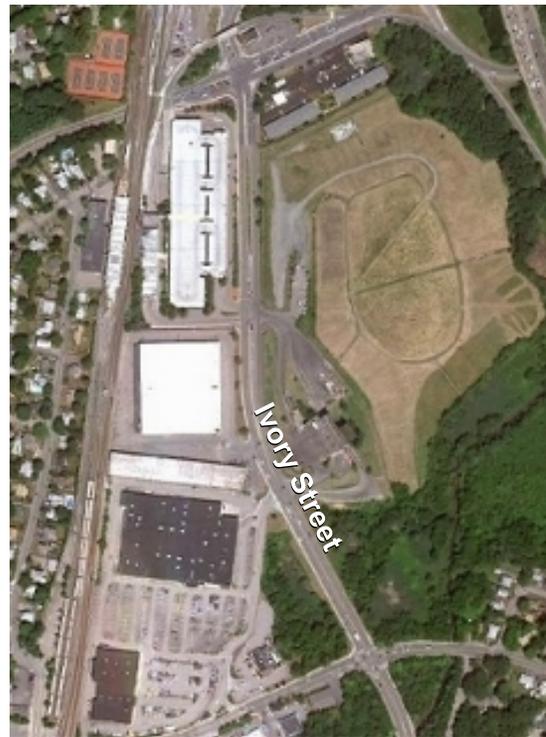
**Ivory Street**

As previously stated, overflow parking for Braintree Station is occurring in the shopping center parking lot located to the south of Braintree Station. Passengers parking here are taking the most direct route to the station, which is through the parking lots rather than along the sidewalk. The west side of Ivory Street between Union and Pearl streets has a 6-foot sidewalk with minimal shade trees and no amenities such as benches or garbage cans.

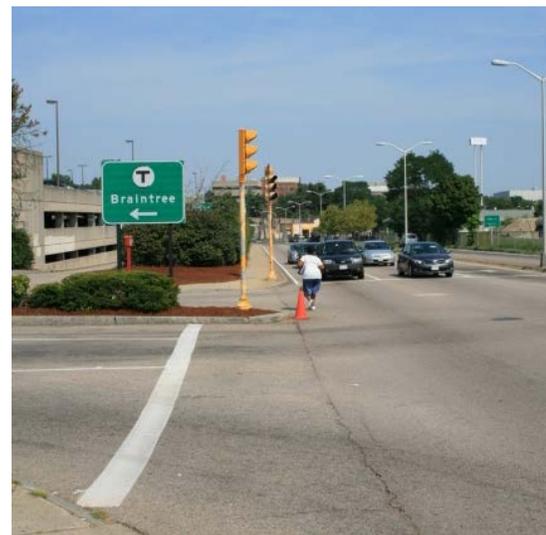
**Ivory Street south of Union Street: Entrance to Braintree Station**

The Braintree Transfer Station, located at 257 Ivory Street, creates an unwelcoming environment for pedestrians due to odor and noise. The transfer station is currently undergoing renovations that will improve aesthetics, help control odor, and reduce noise pollution. The renovations will also include access improvements, which will reduce the queue of trucks. These renovations will improve the environment along Ivory Street for pedestrians.

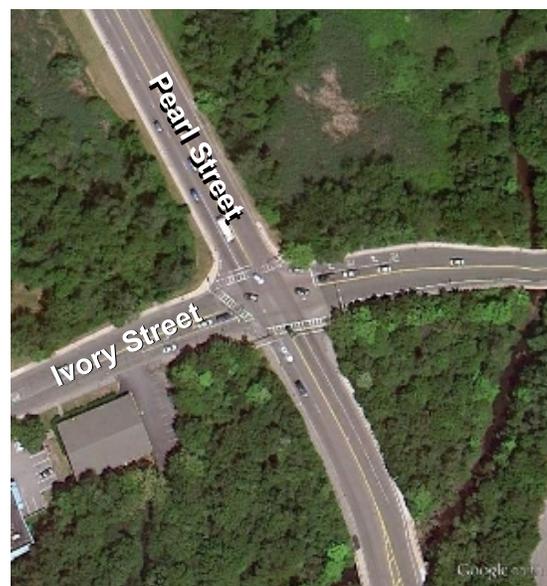
**Ivory Street and Pearl Street**

There were a total of 47 crashes, including one involving a pedestrian, between 2005 and 2009 at the intersection of Ivory Street and Pearl Street. Pearl Street, which is under the jurisdiction of the Town of Braintree, has two travel lanes, runs in an east-west direction, and is classified as an urban collector road. This intersection is signalized. There is on-street parking on both sides of Pearl Street west of the rail corridor underpass. As Pearl Street approaches Ivory Street from the west, there is one shared through/right lane and one left-turn lane. As Pearl Street approaches Ivory Street from the east, there is one through lane and one right-turn-only lane. During the site visit, moderate traffic volumes and speeds were
